Jaipur Terminal Fire of 29.10.2009

By
SK Roy, GM(HSE),CO
Indian Oil Corporation Limited

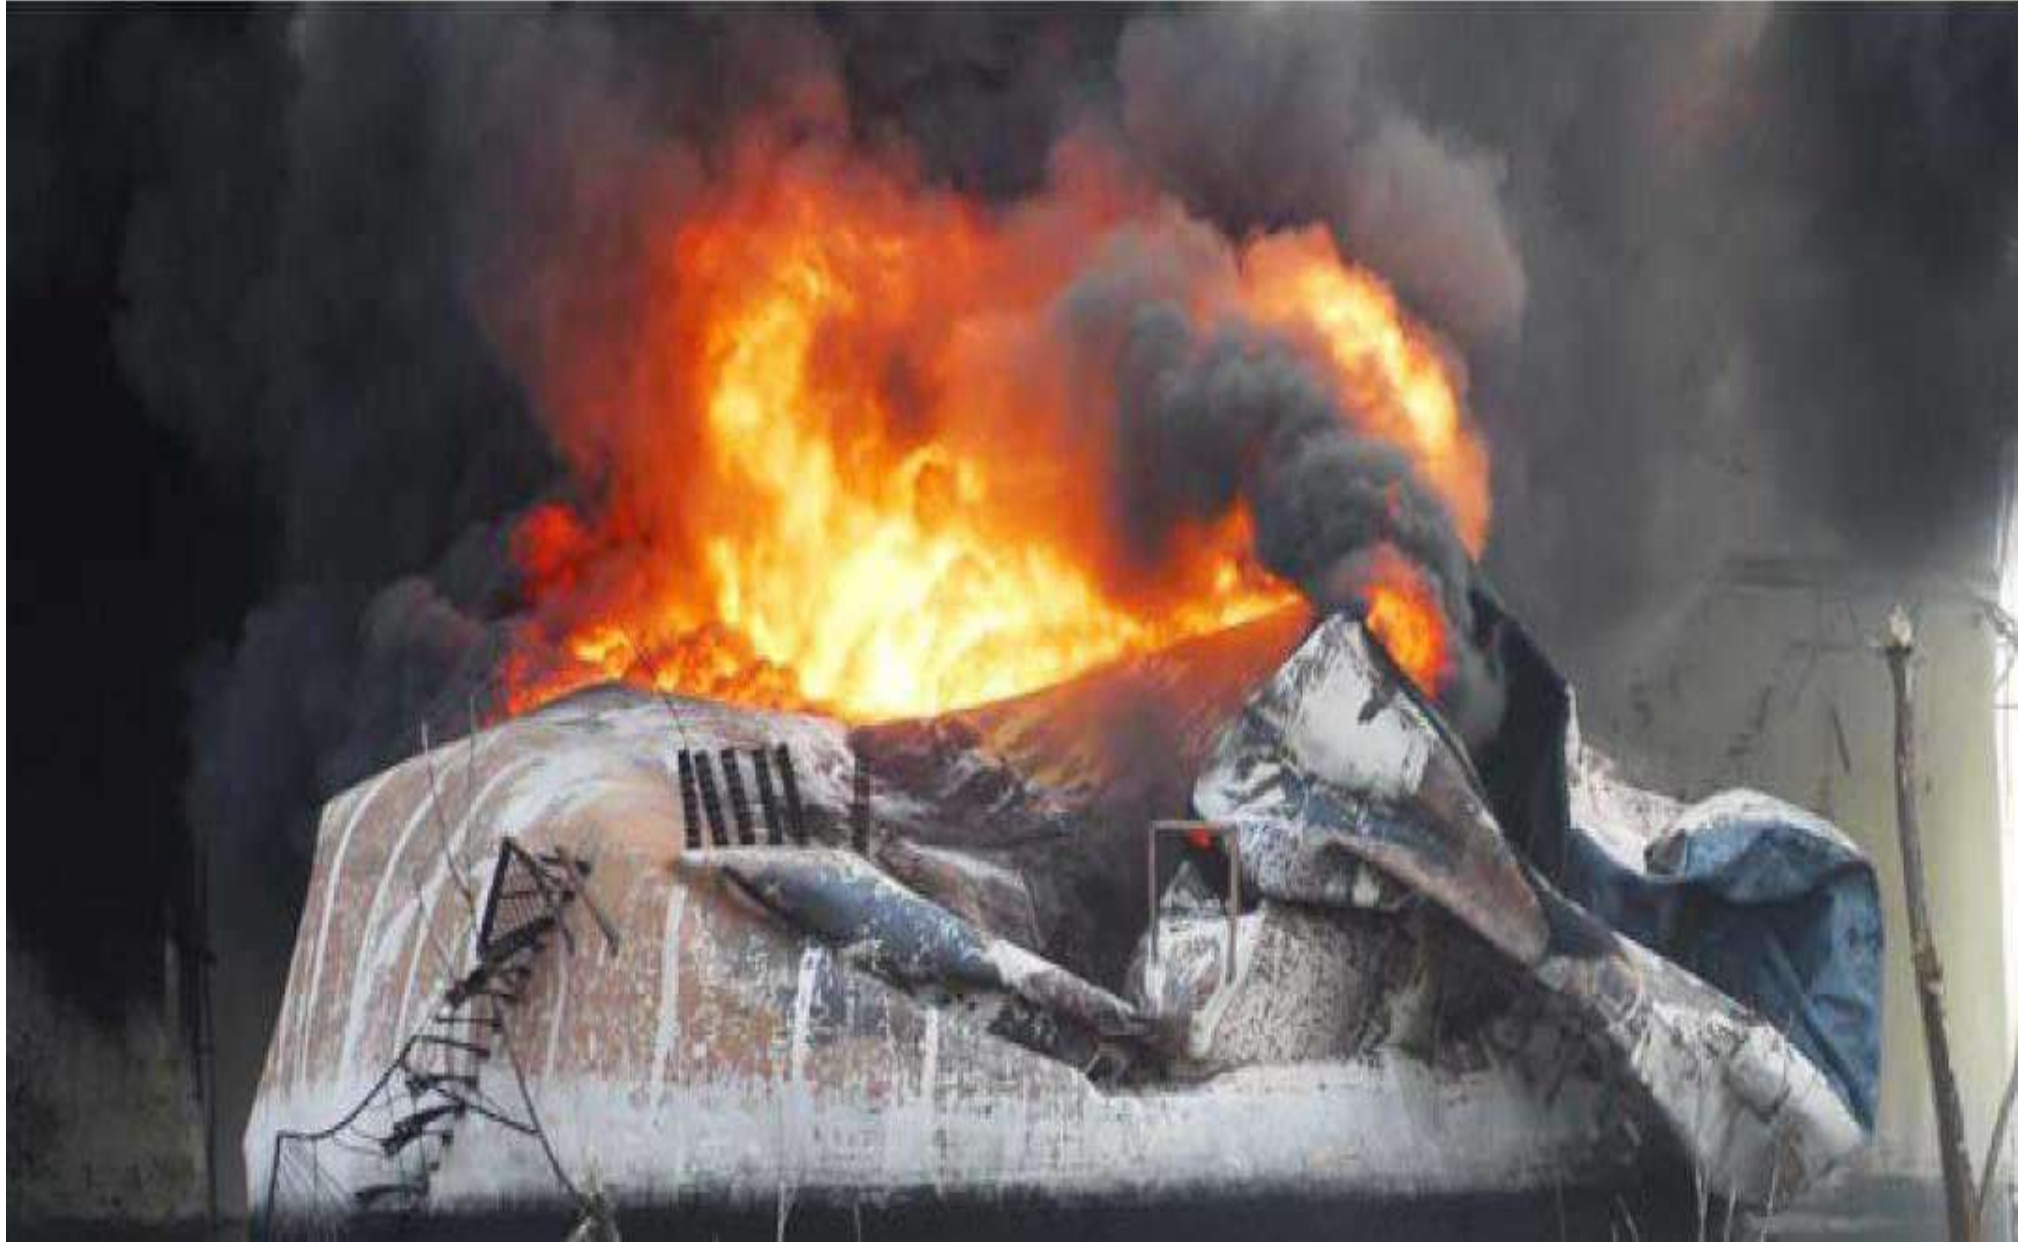
MS Tank collapsed

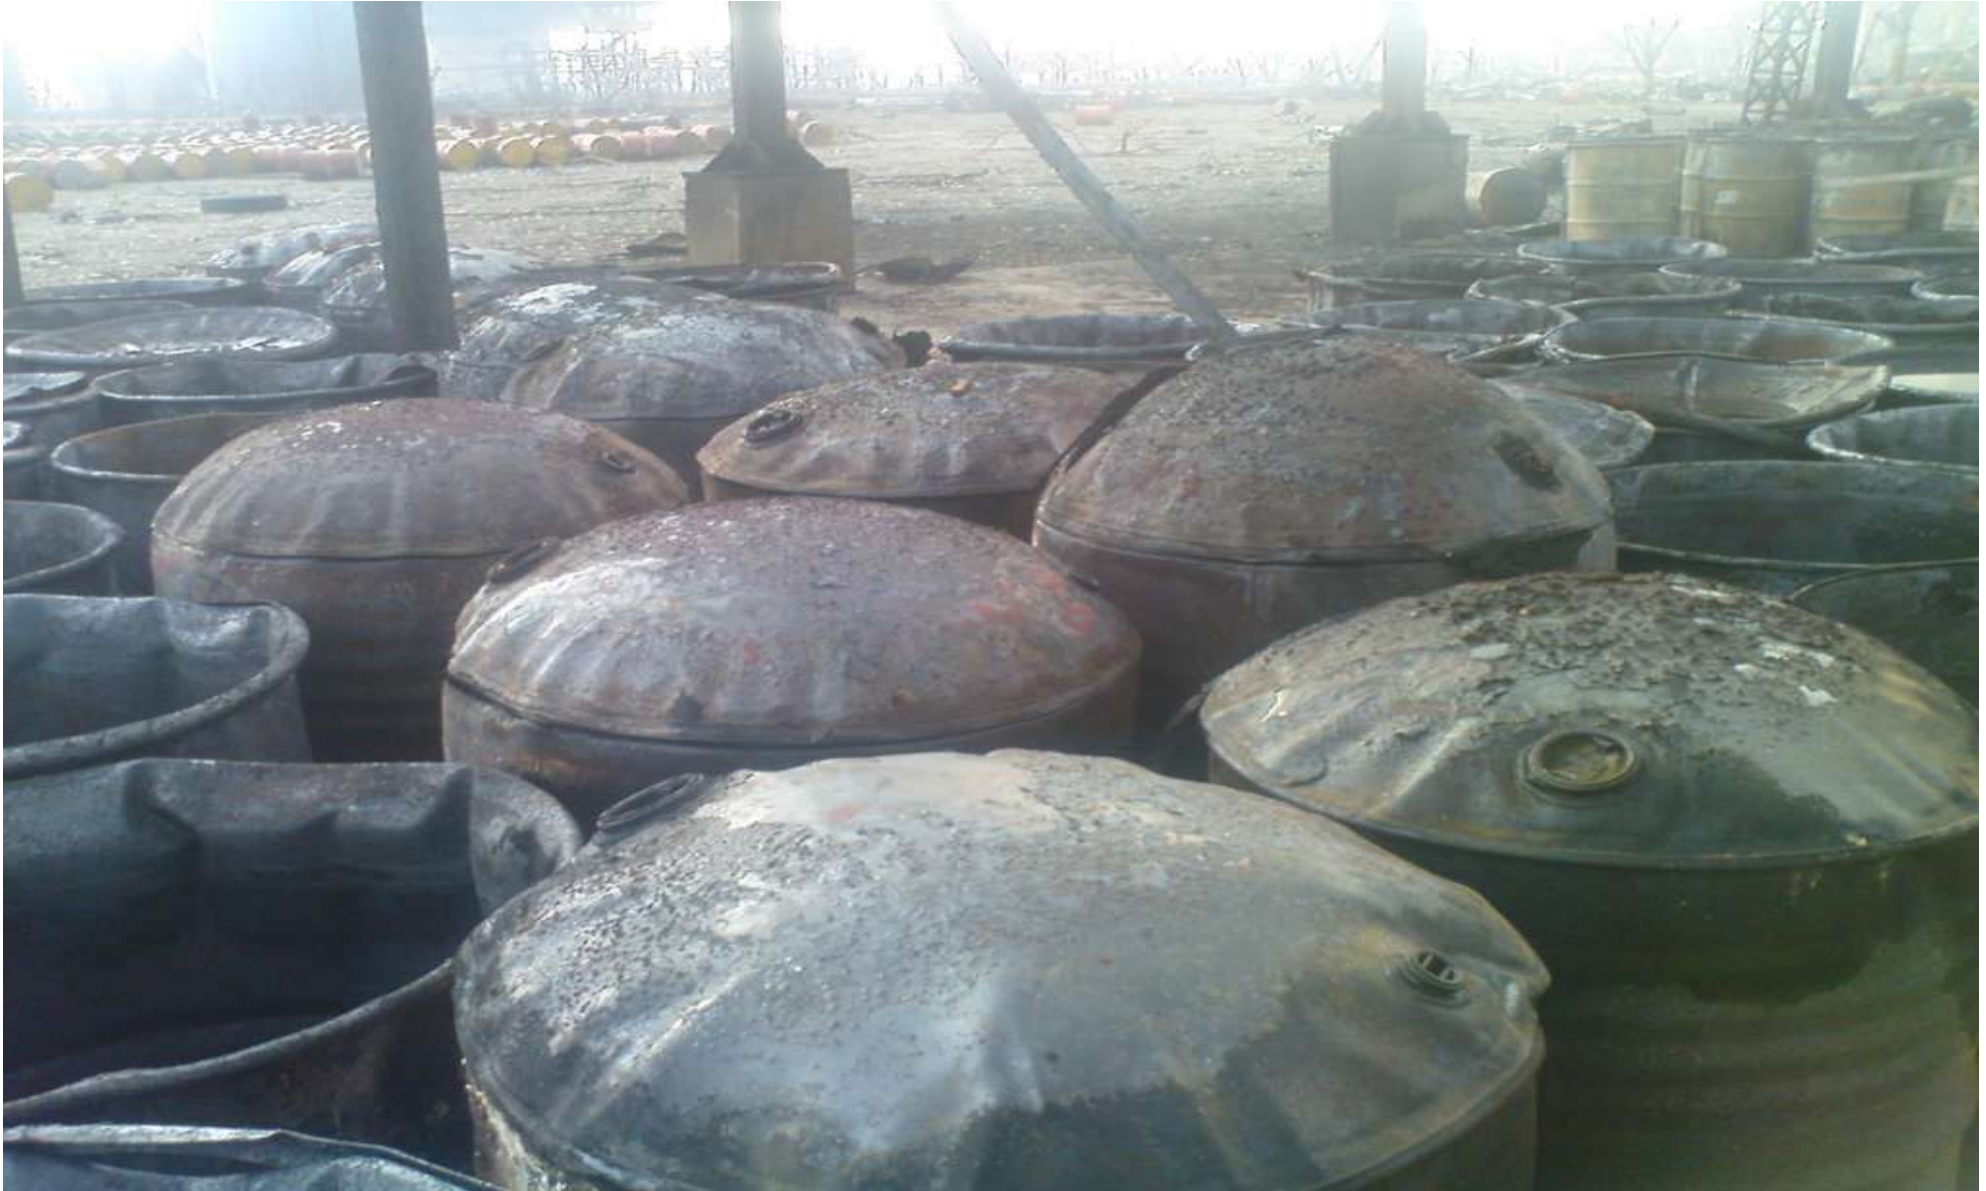
Over pressurised Lube oil Drums near tanks in Fire Many Exploded

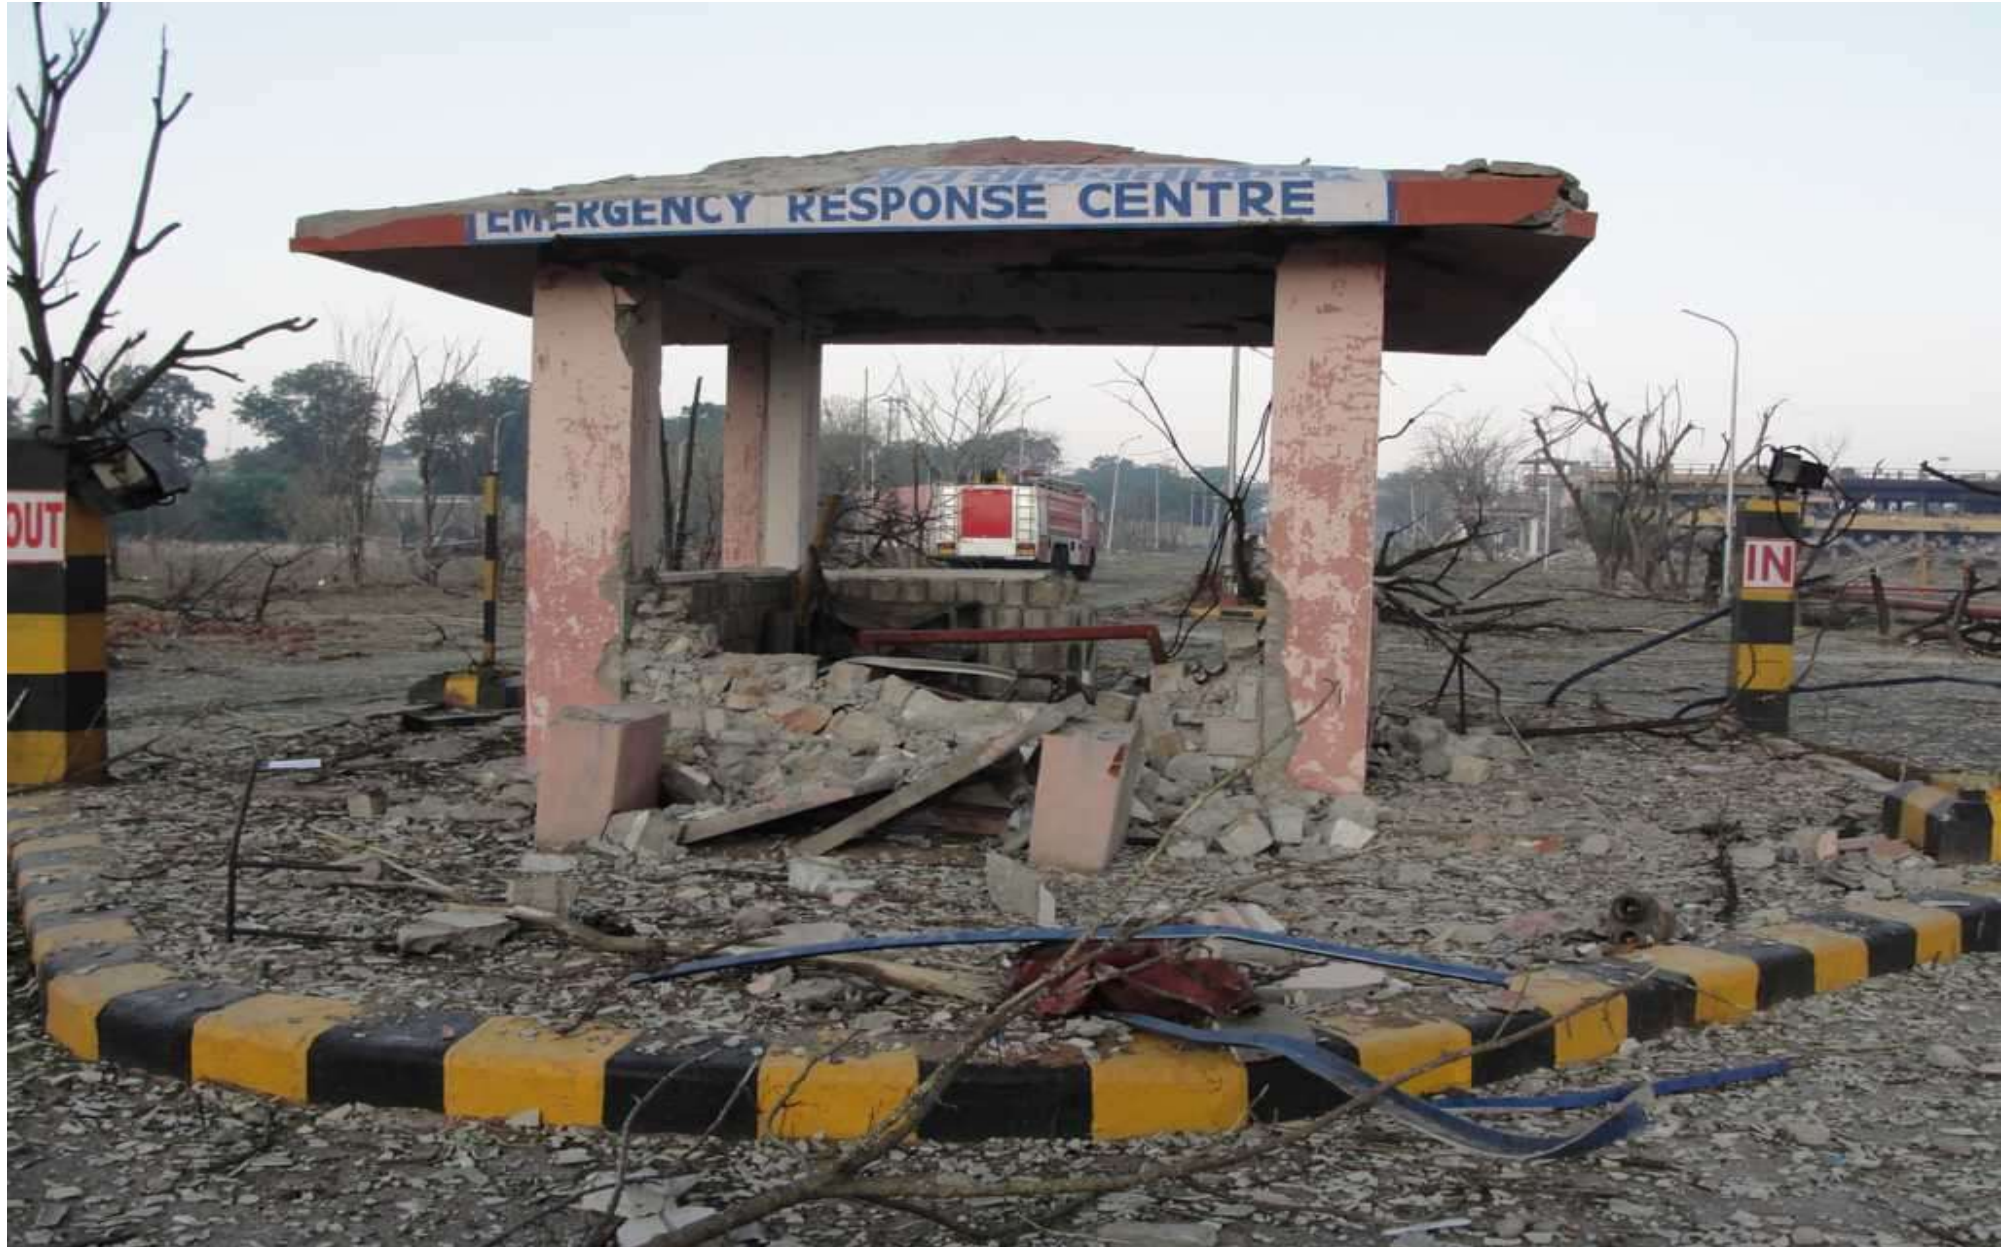
Demolished Emergency Response Centre near Gate

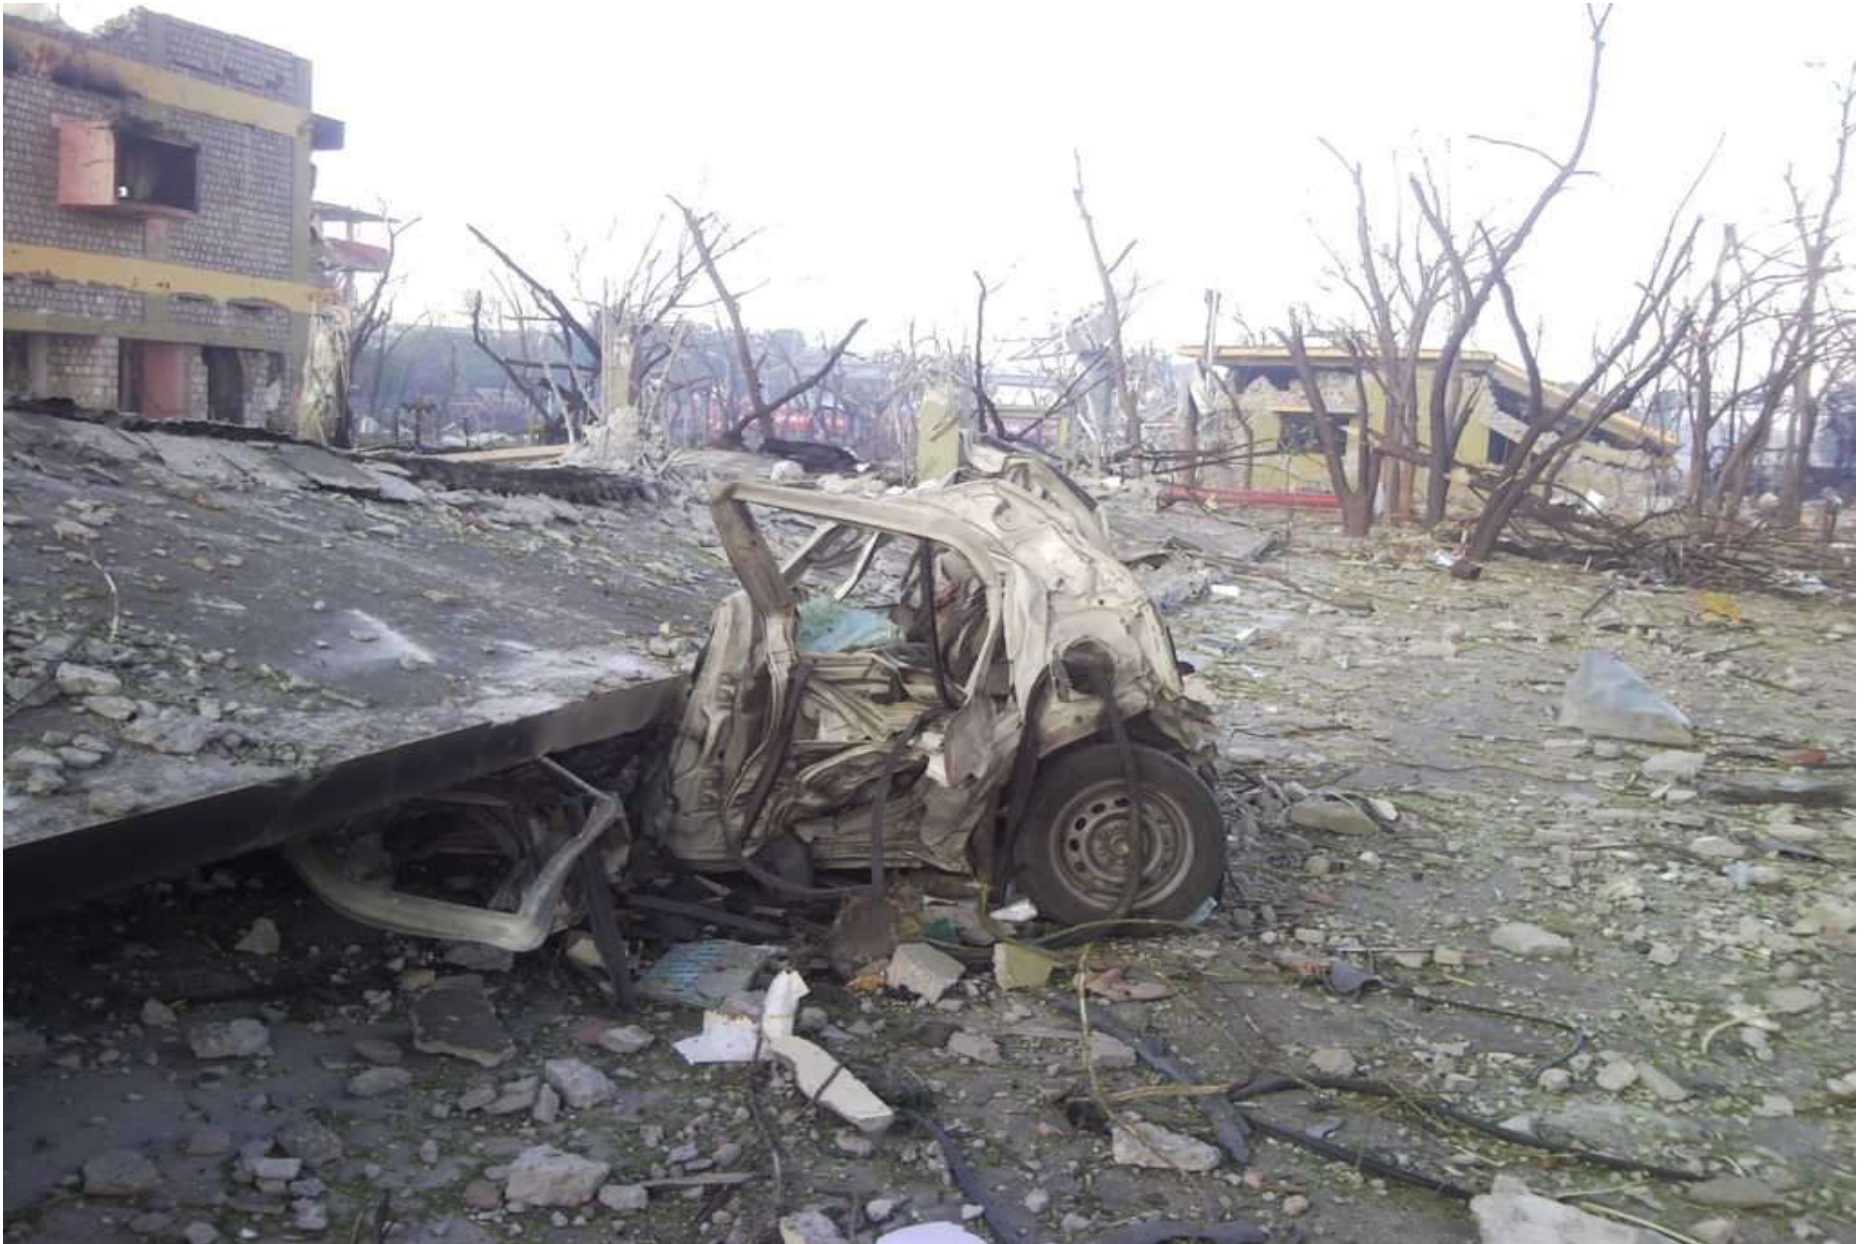
Collapsed car shed in the terminal

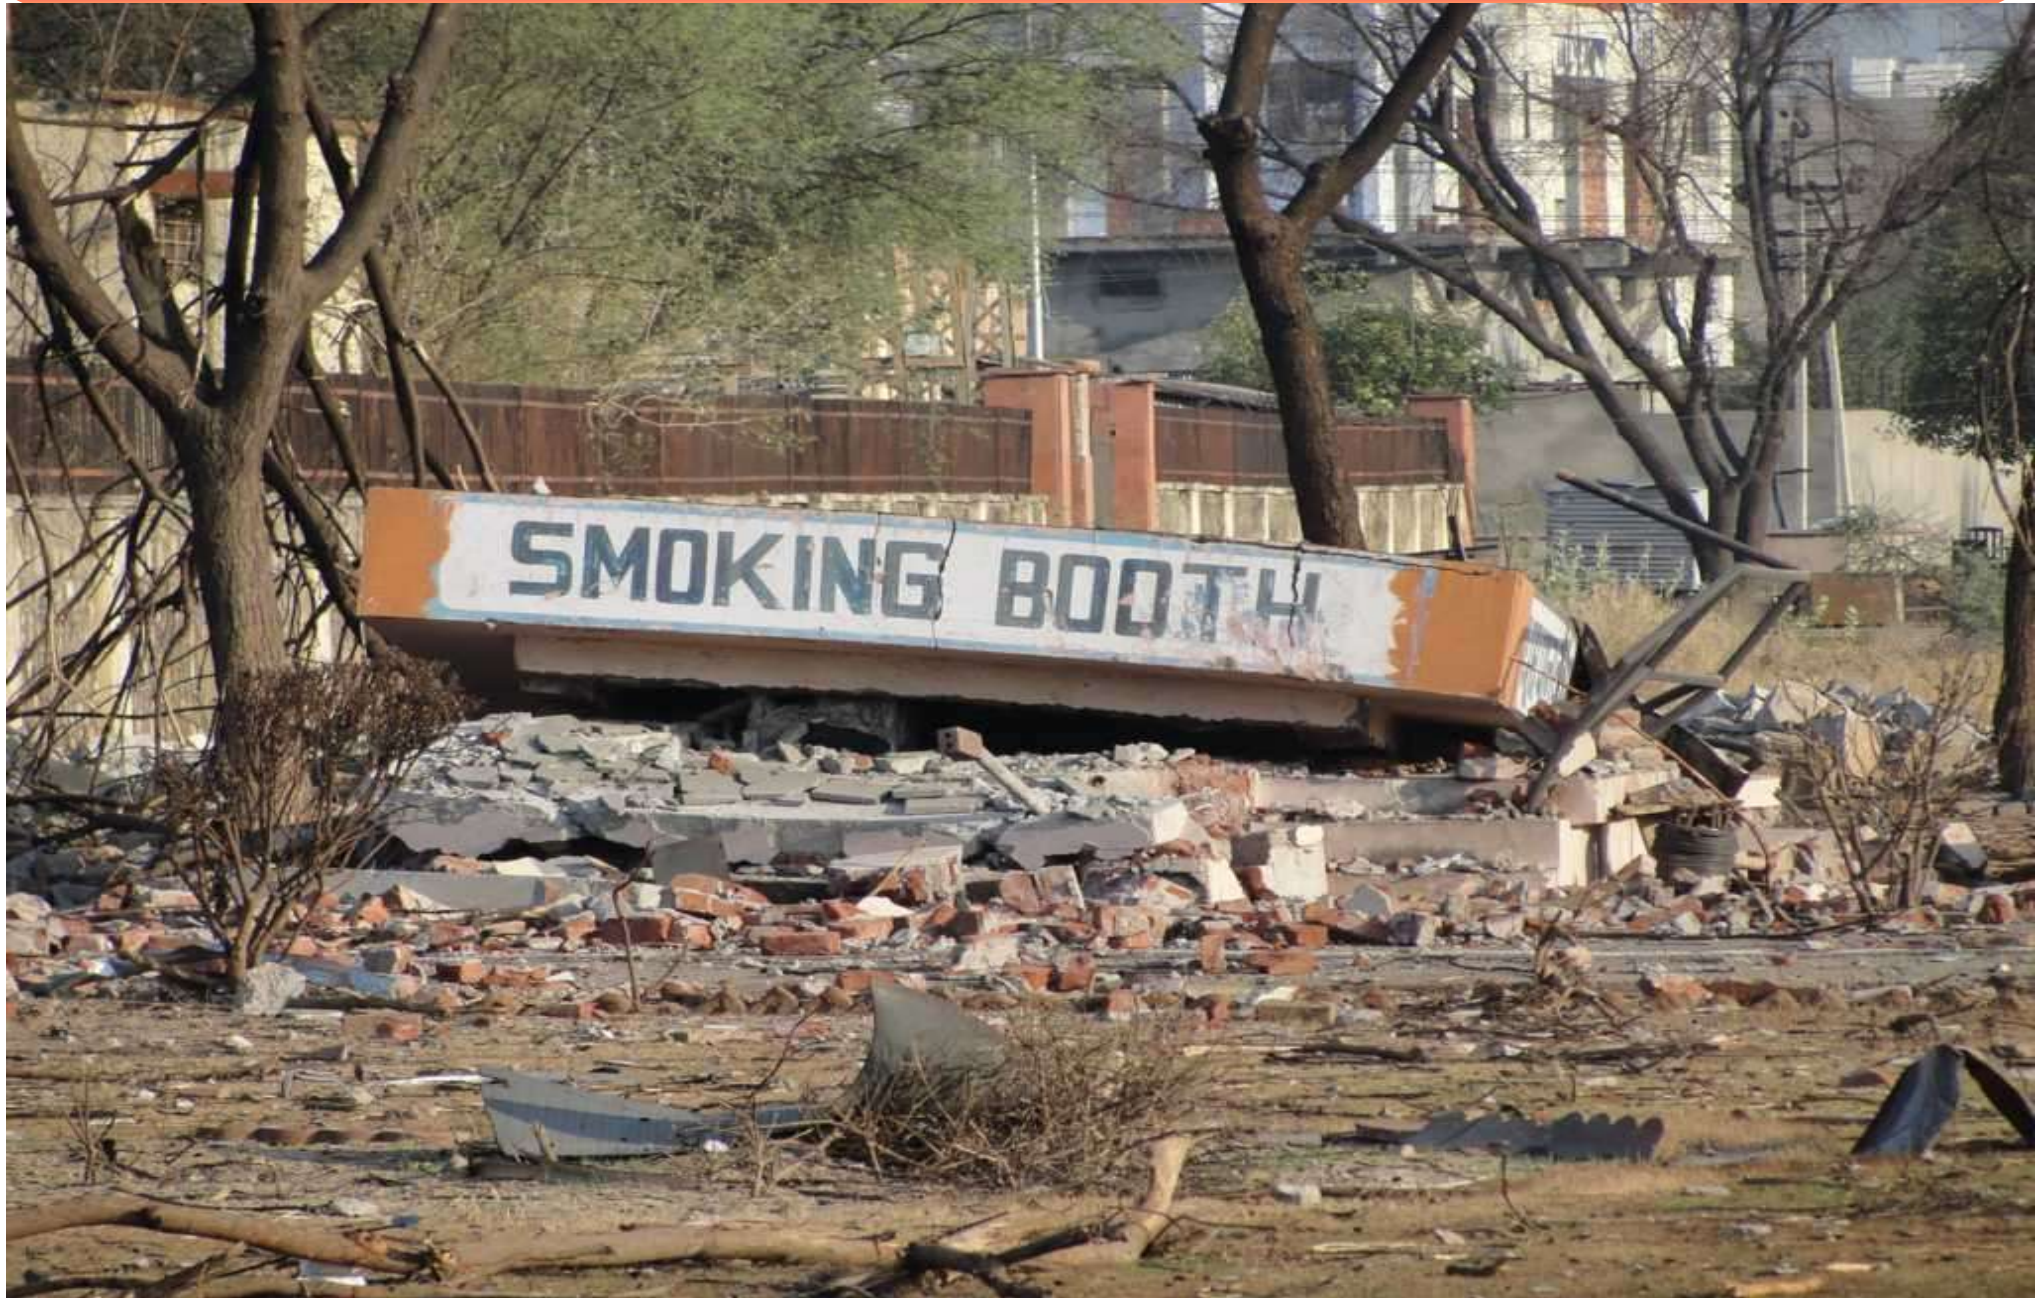
Demolished Smoking Booth near Boundary Wall

- ❑ As Vapour Cloud spread in such a large area , the source of fire can be anything inside or outside the installation.
- ❑ The **Non flame proof electrical fittings** in administration block located in the south western direction of the terminal or **Spark during starting of the vehicle** at the installation are probable cause of source of fire.

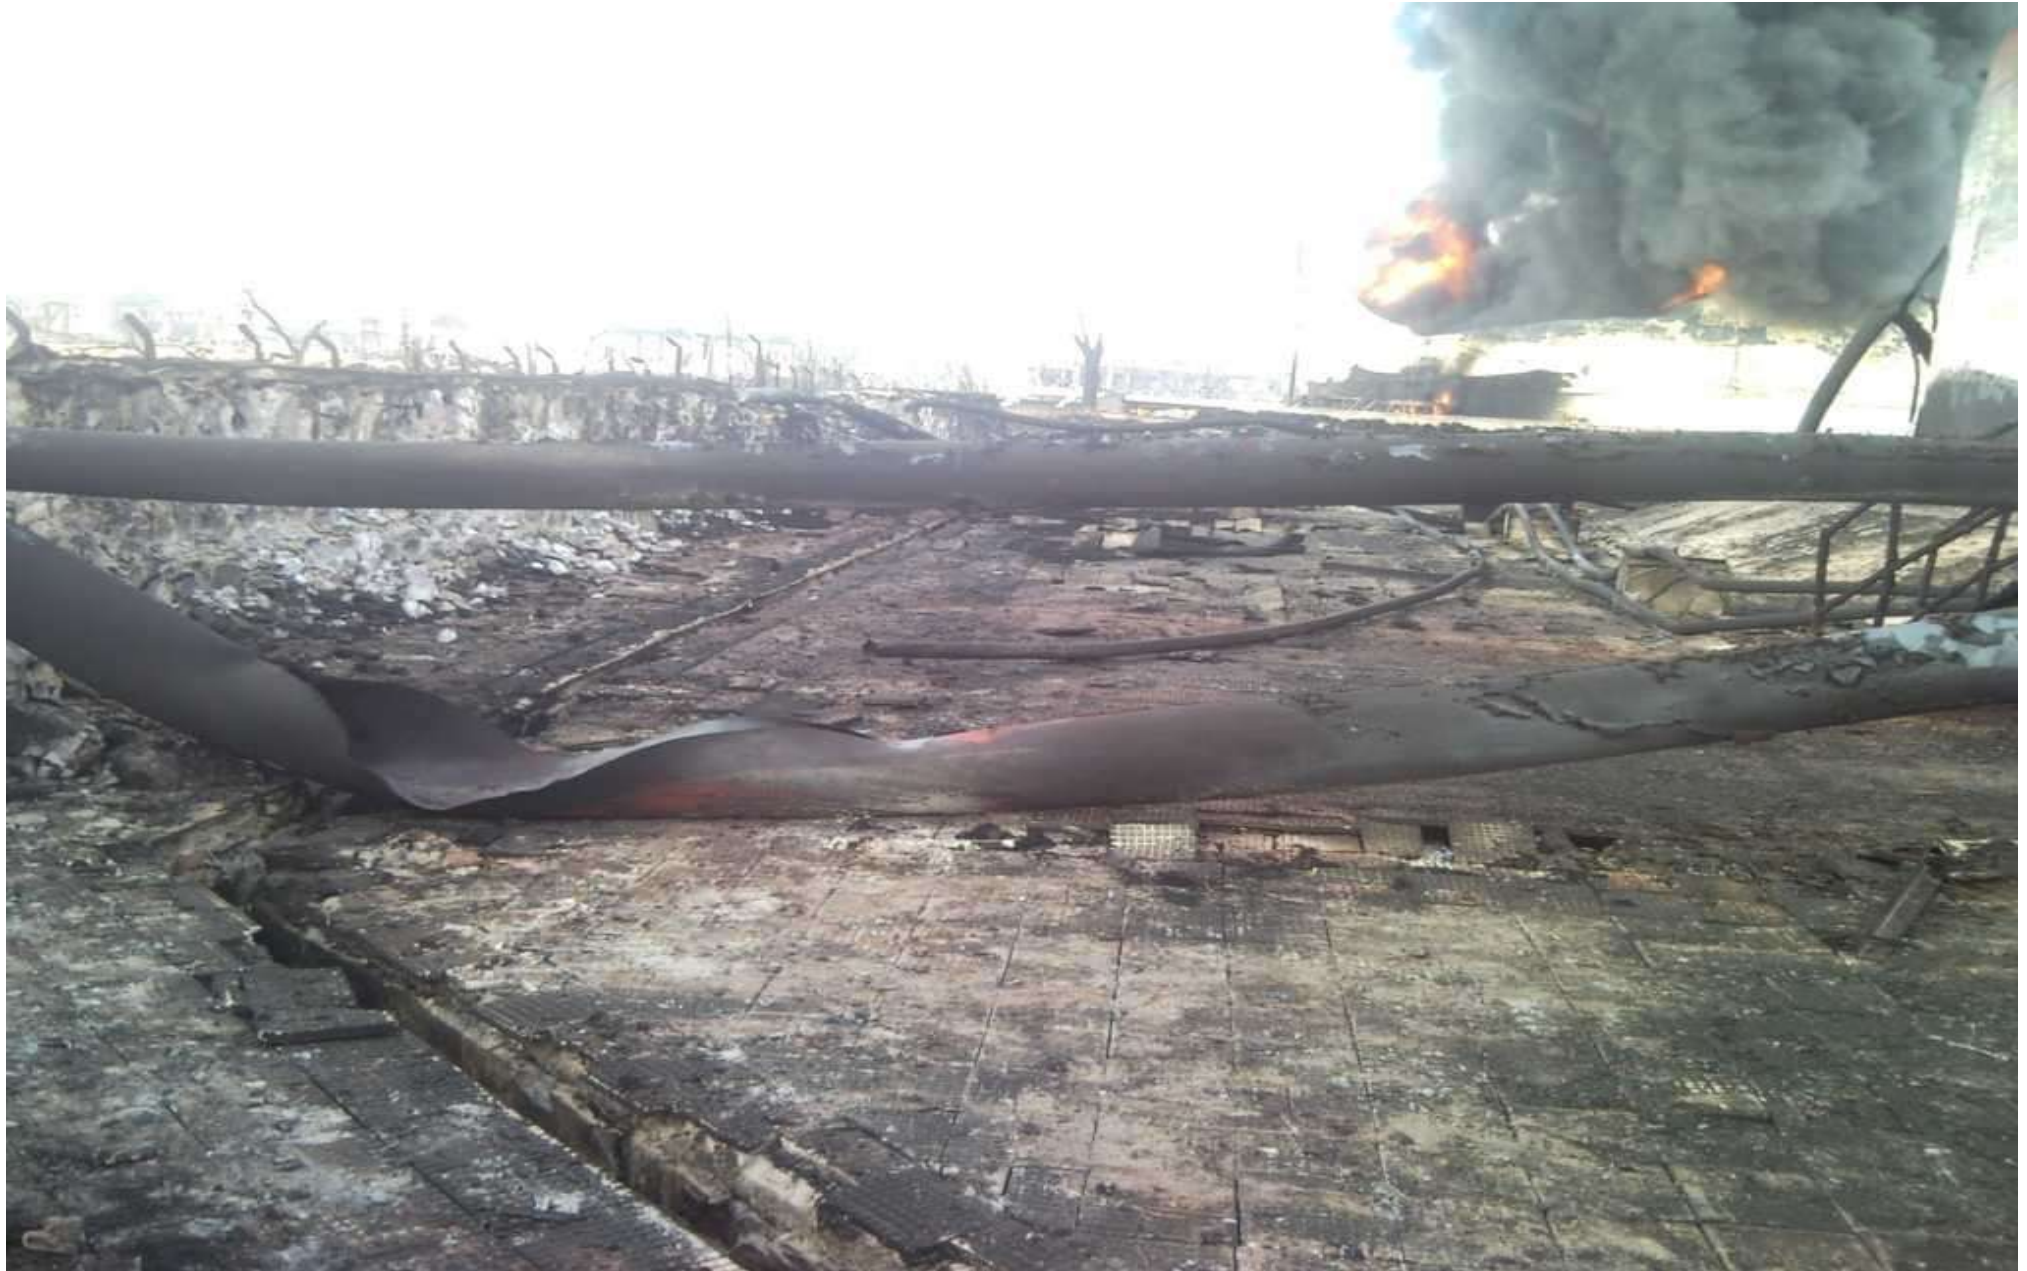
Ruptured pipelines

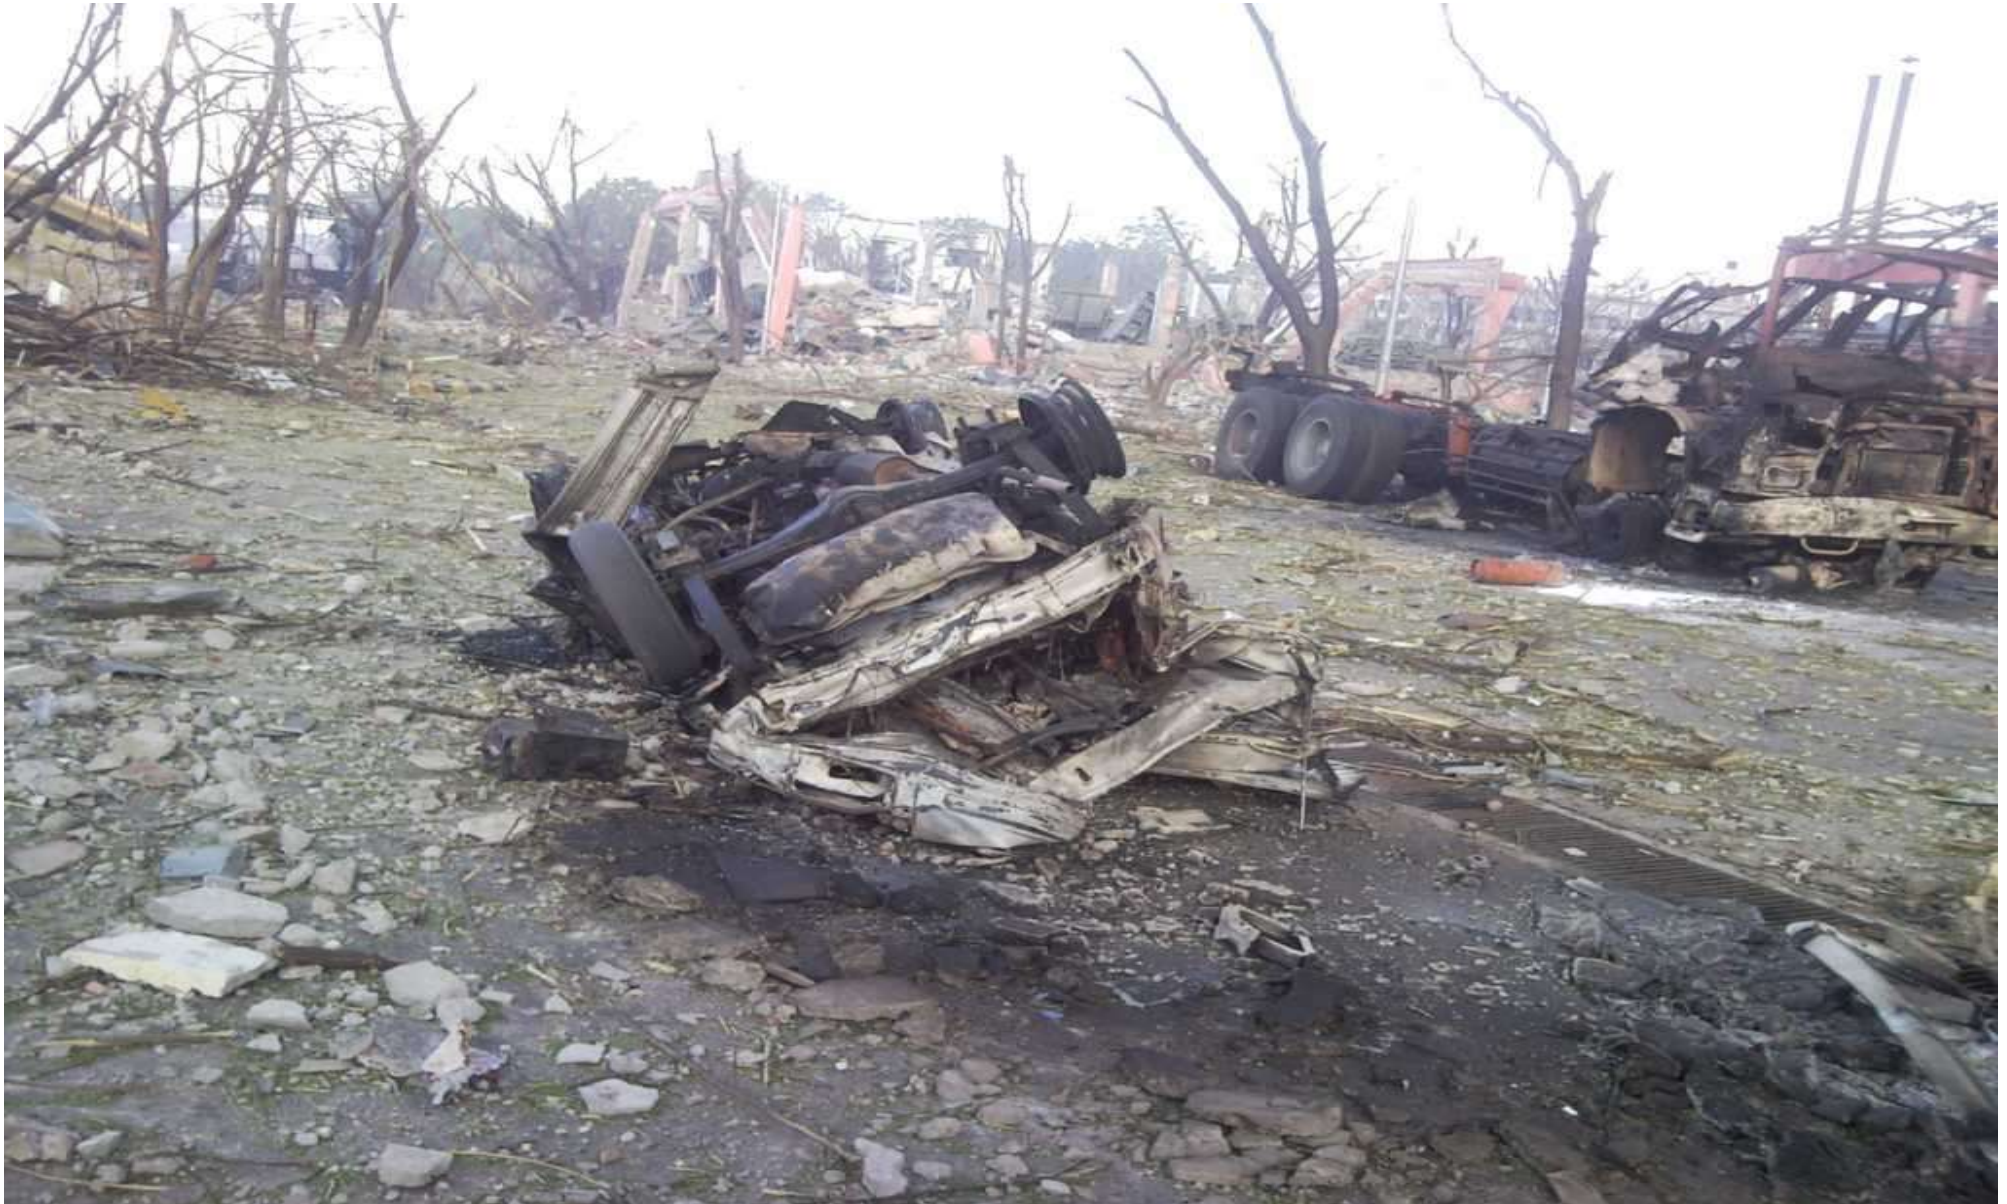
Damage to Vehicles

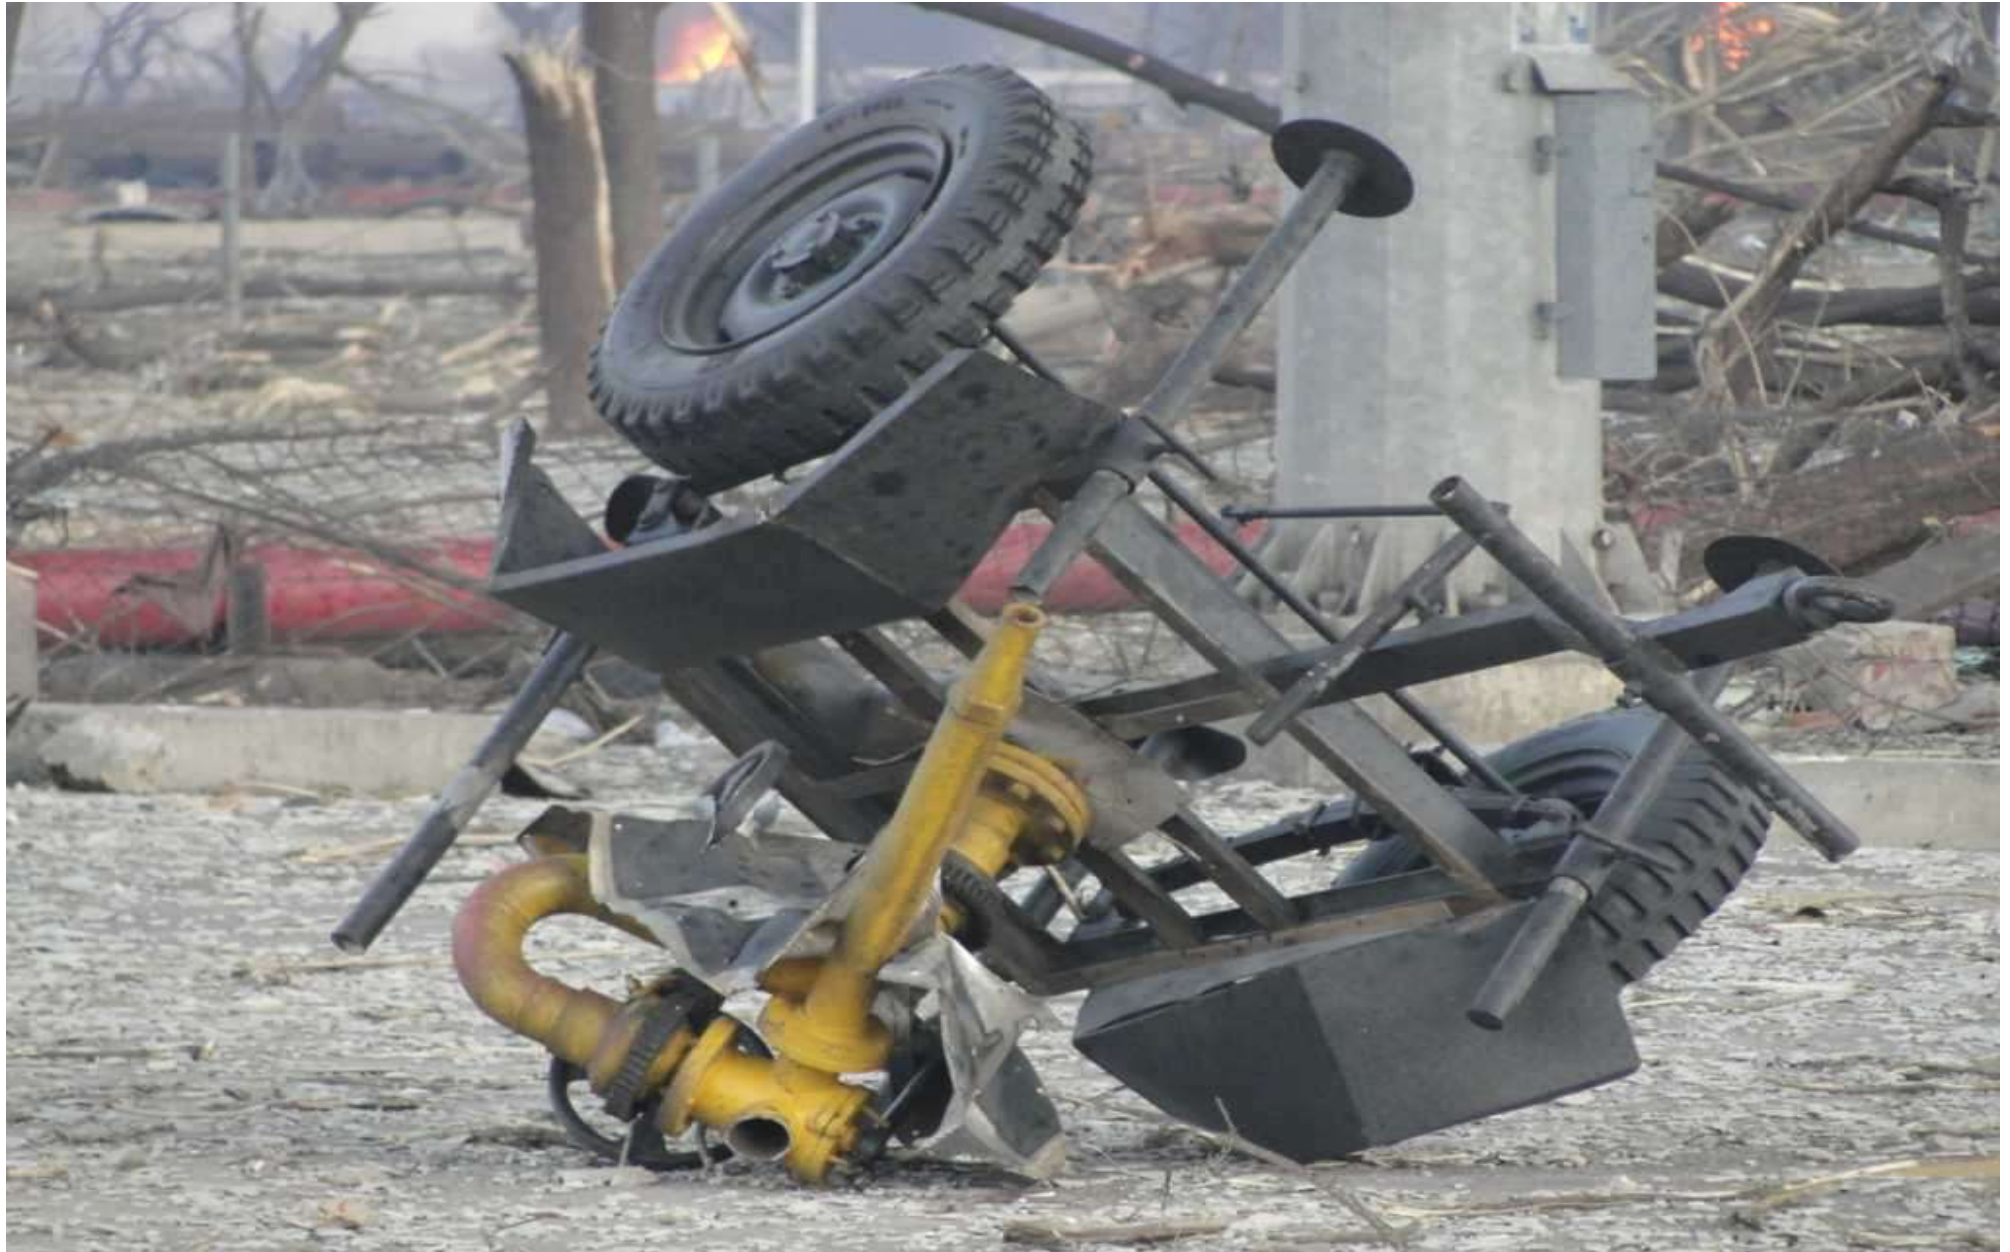
Overturned Fire Monitor.

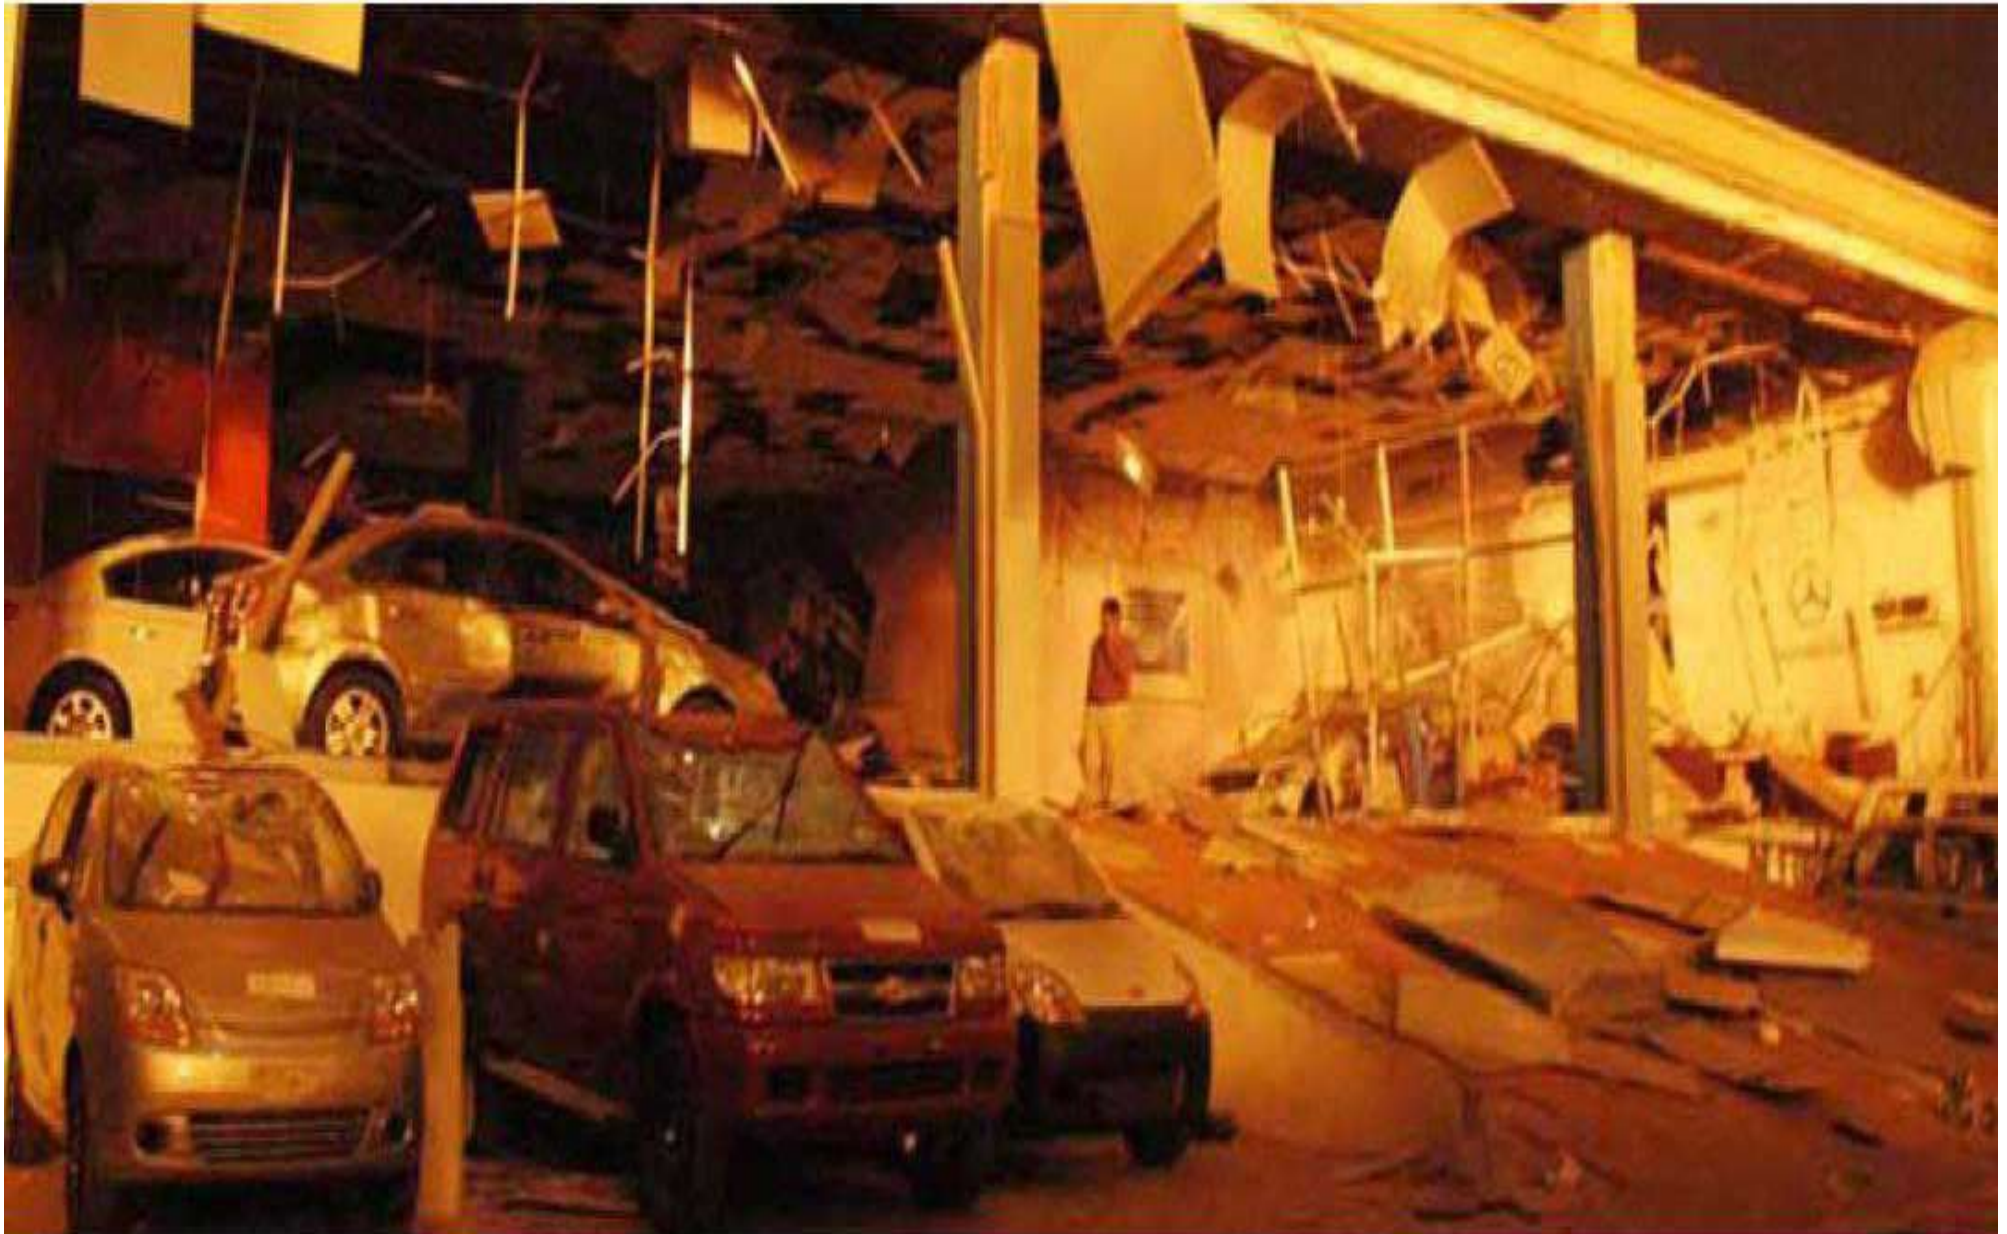
Damage at nearby car Showroom
