Jaipur Terminal Fire of 29.10.2009

By
SK Roy, GM(HSE),CO
Indian Oil Corporation Limited

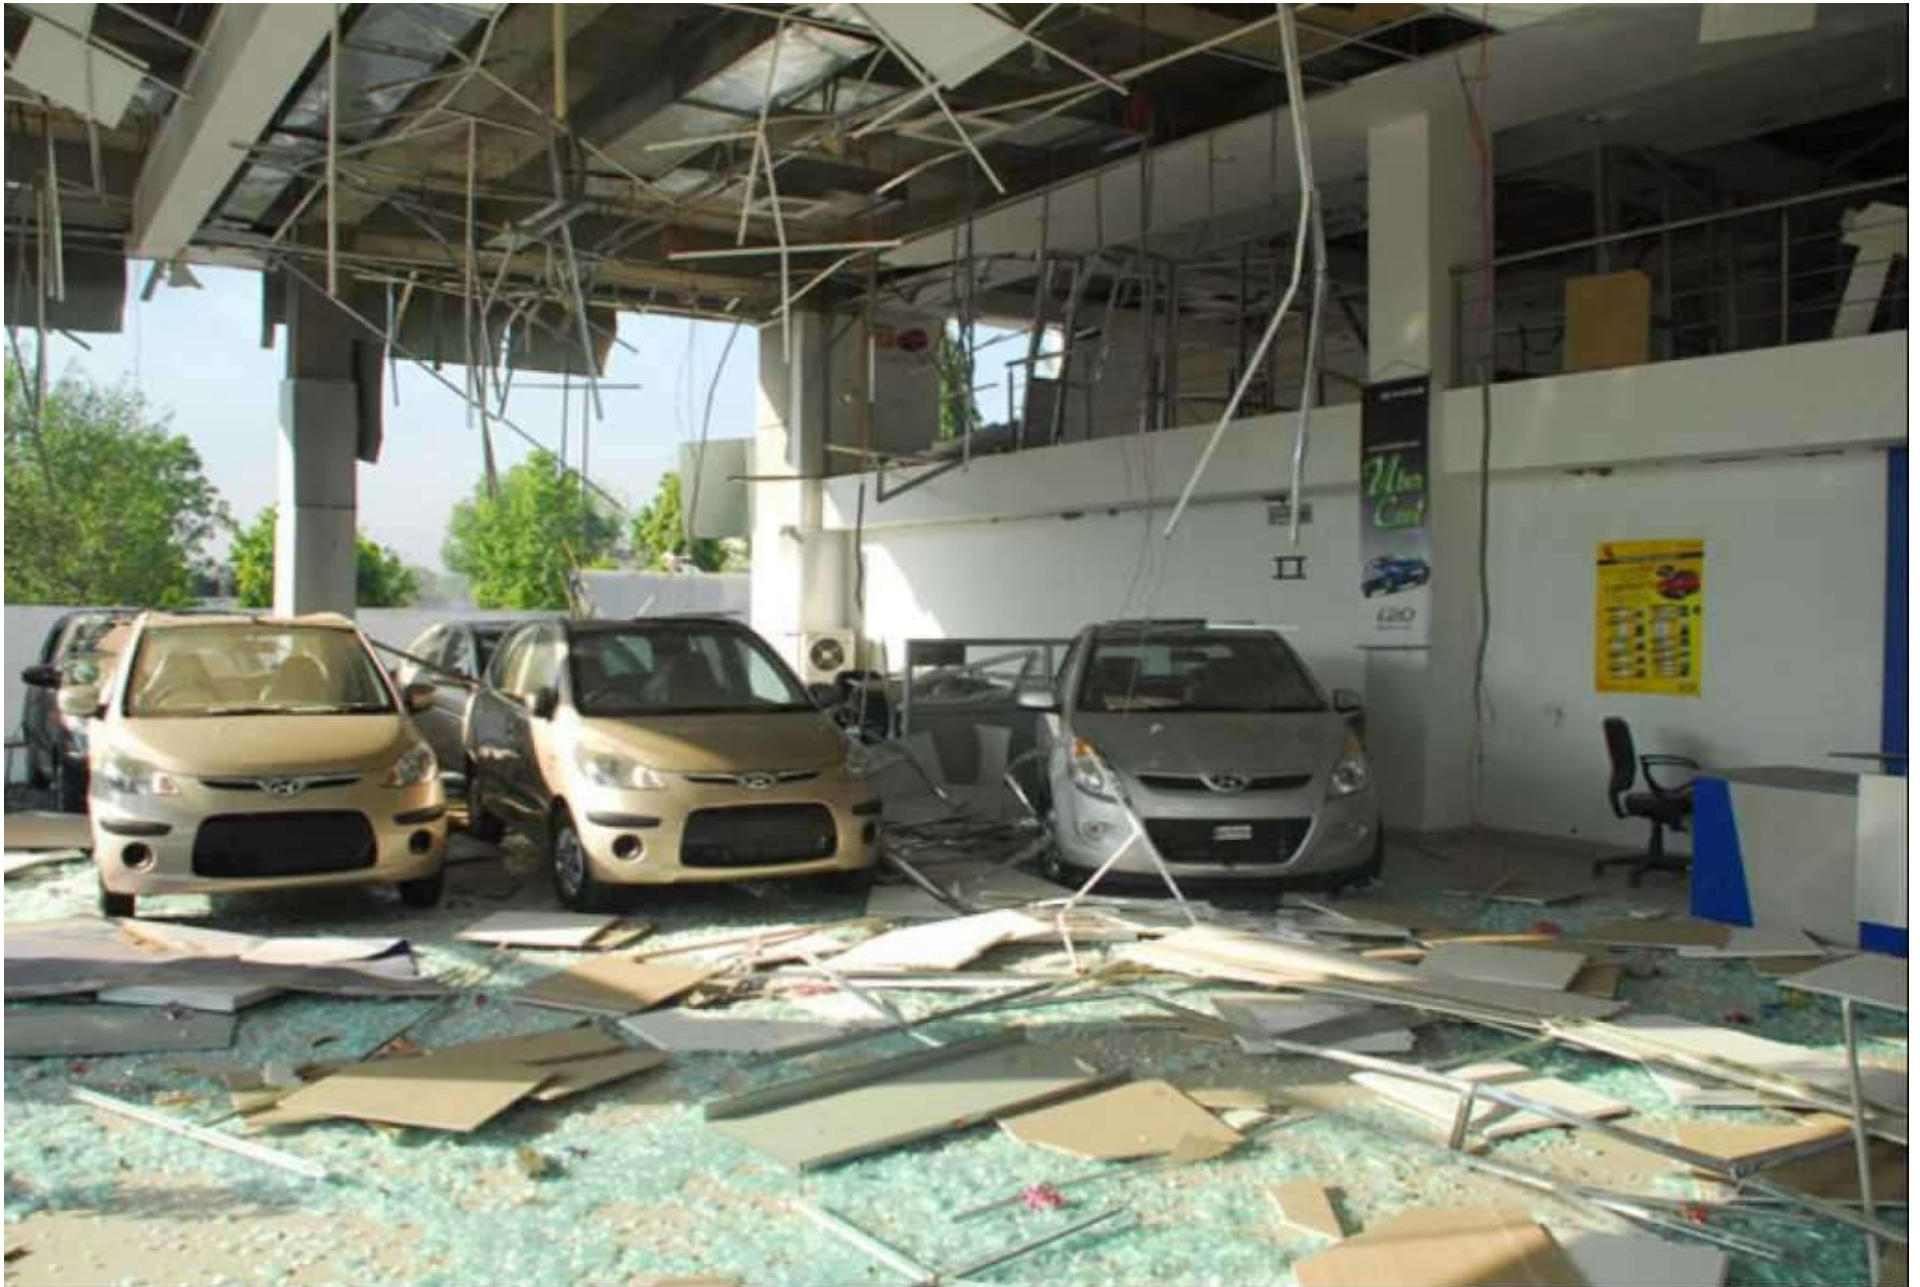
Damage at nearby car Showroom

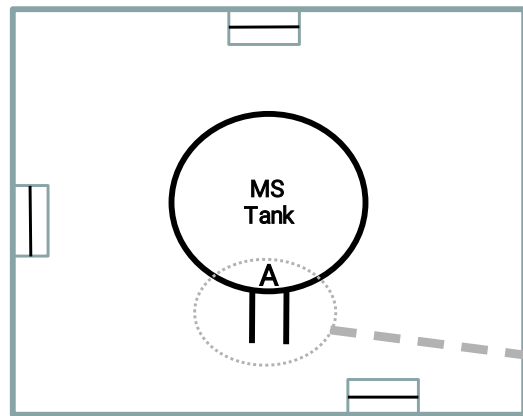
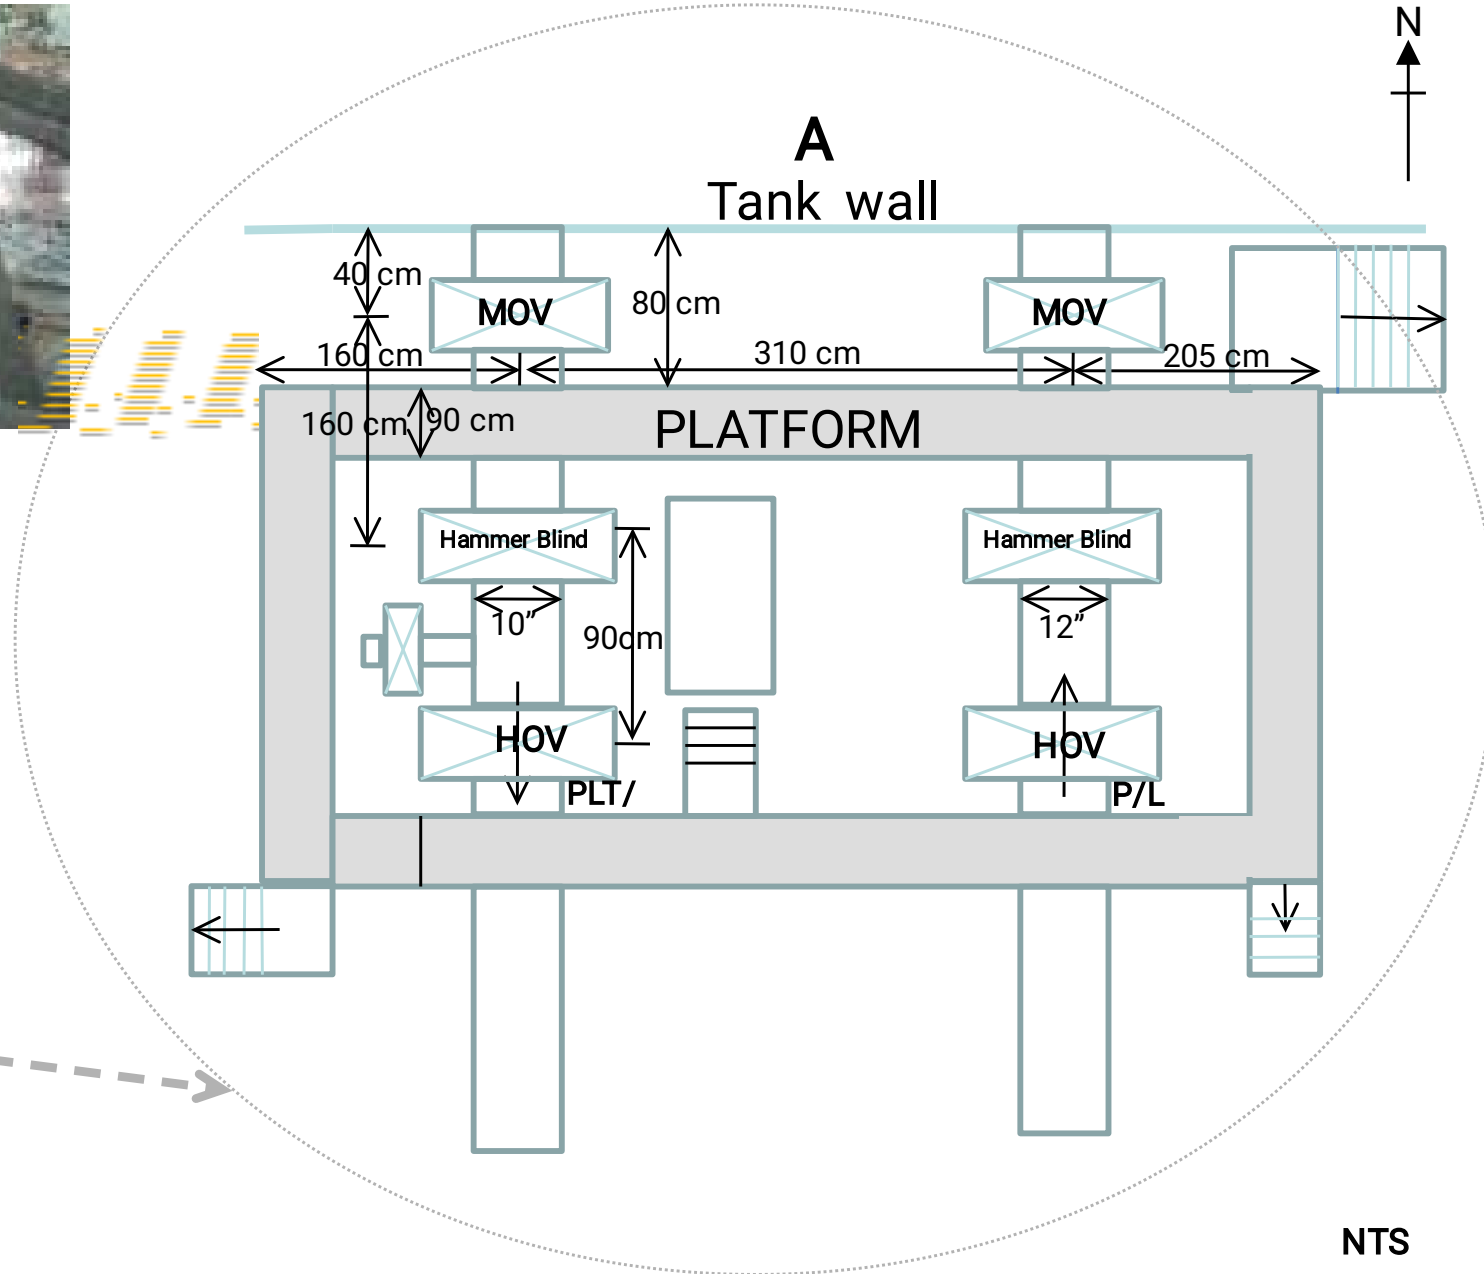
Schematic of Valves on Tank Discharge Line

Standard Operating Sequence	Likely Sequence
<ol style="list-style-type: none"> 1. Ensure MOV and HOV are closed 2. Reverse the position of Hammer Blind Valve 3. Open the HOV 4. Open MOV (initially inching operation to establish no leakage from Hammer Blind Valve body) 	<ol style="list-style-type: none"> 1. MOV opened first. 2. Hammer Blind Valve opened 3. Leakage started.

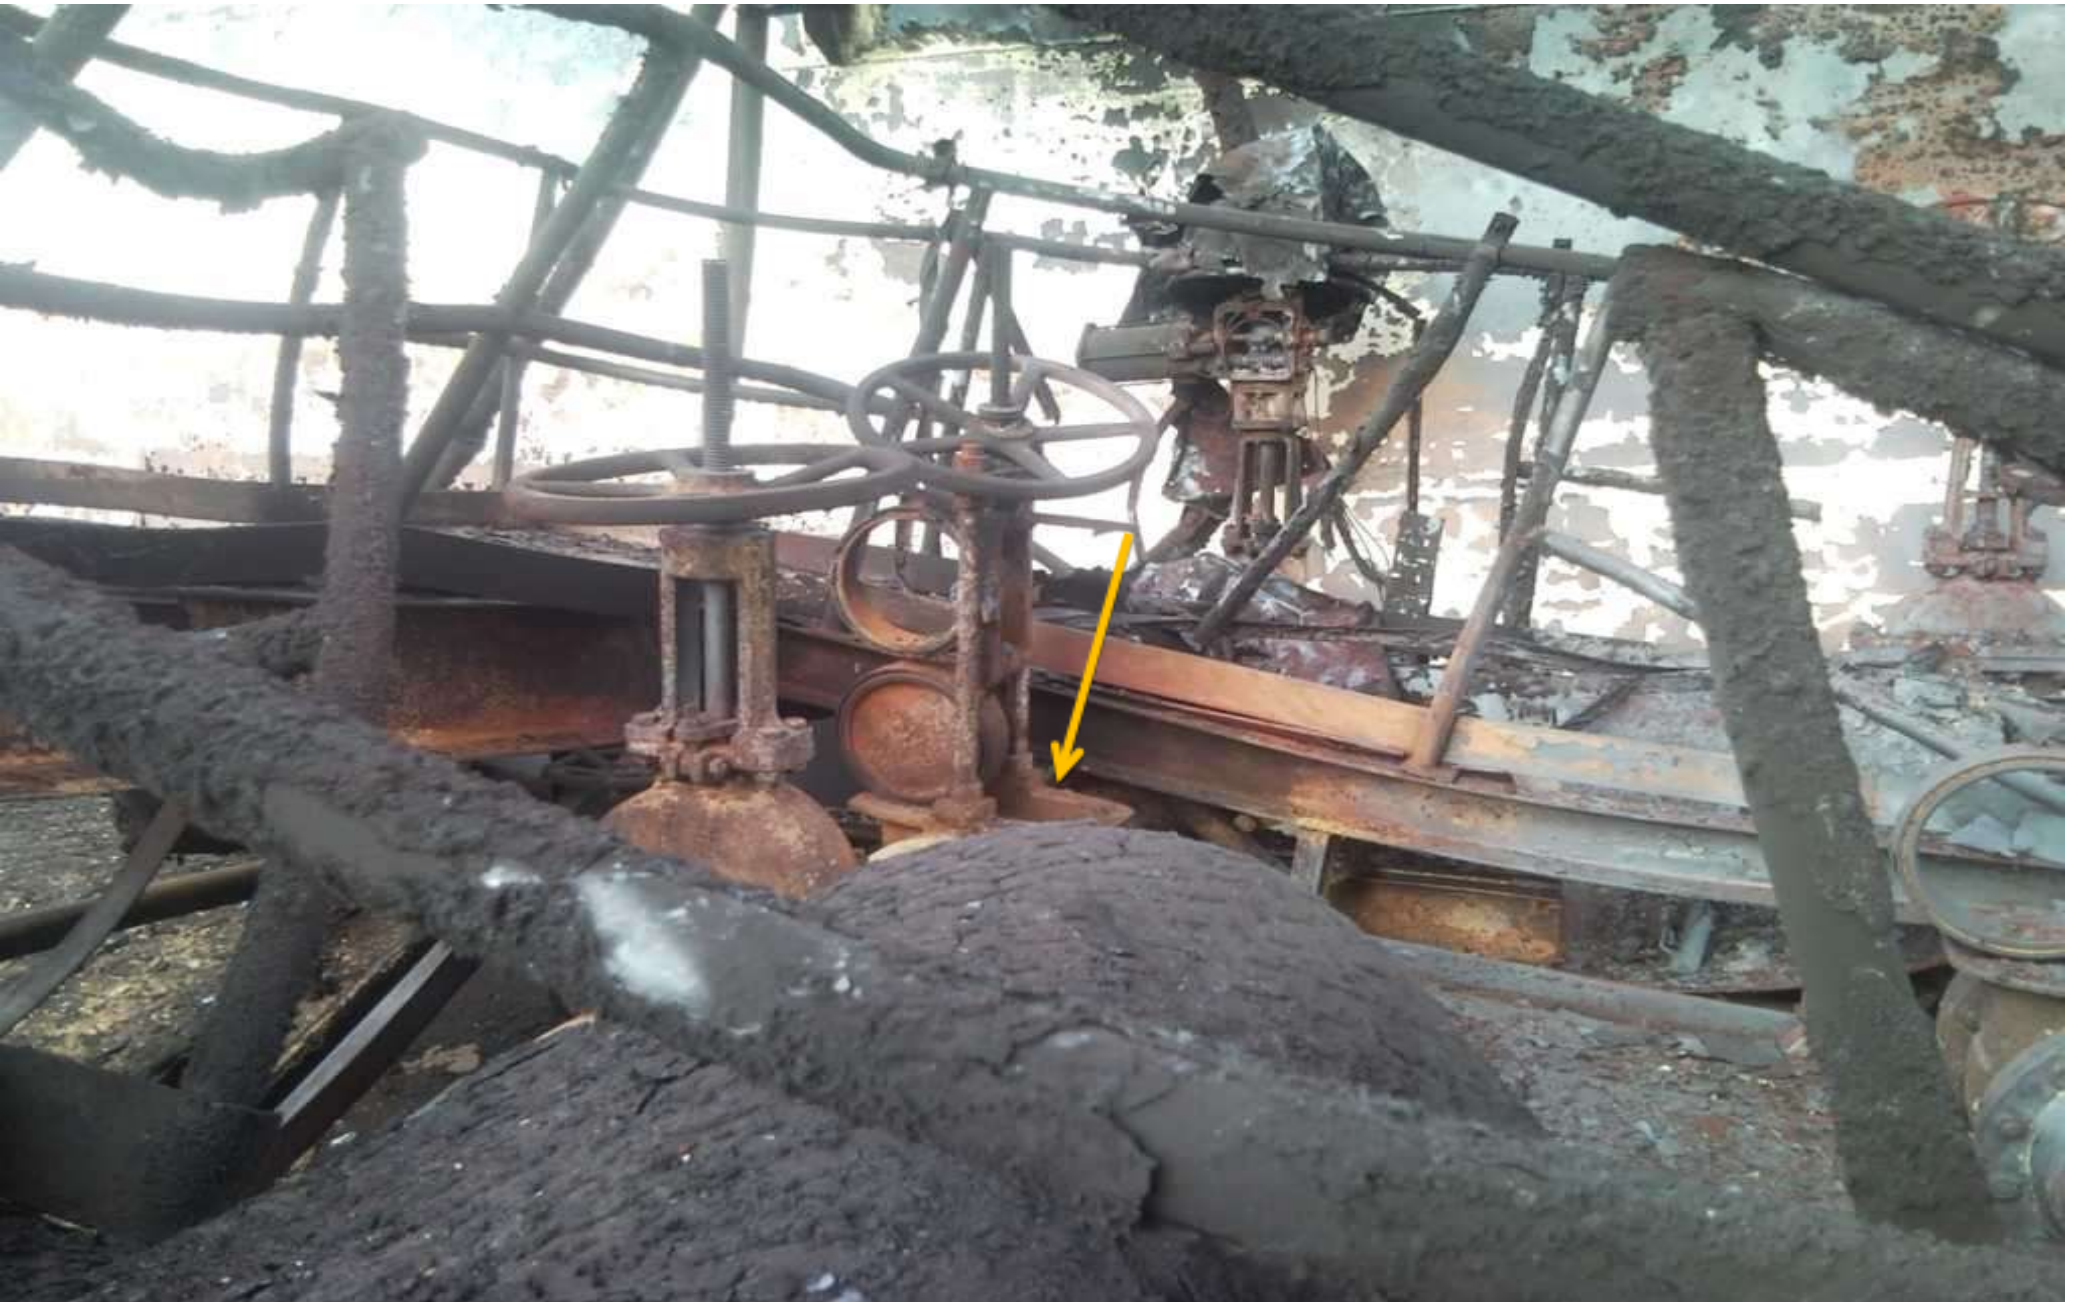
Source of MS Leak

Amongst the two Scenarios, Scenarios-I, that the MOV was in open condition before the start of the hammer blind reversal job, appear to be more likely.

- ❑ Only a closed system design should be adopted. All Hammer Blind valves should be replaced with Pressure Balancing type Plug Valves / Ball Valves.
- ❑ The first body valve on the tank should be Remote Operated Shut Off Valve (ROSOV) on the tank nozzle inside the dyke with Remote Operation from outside the dyke as well as from the control room. ROSOV should be fail safe and fire safe.

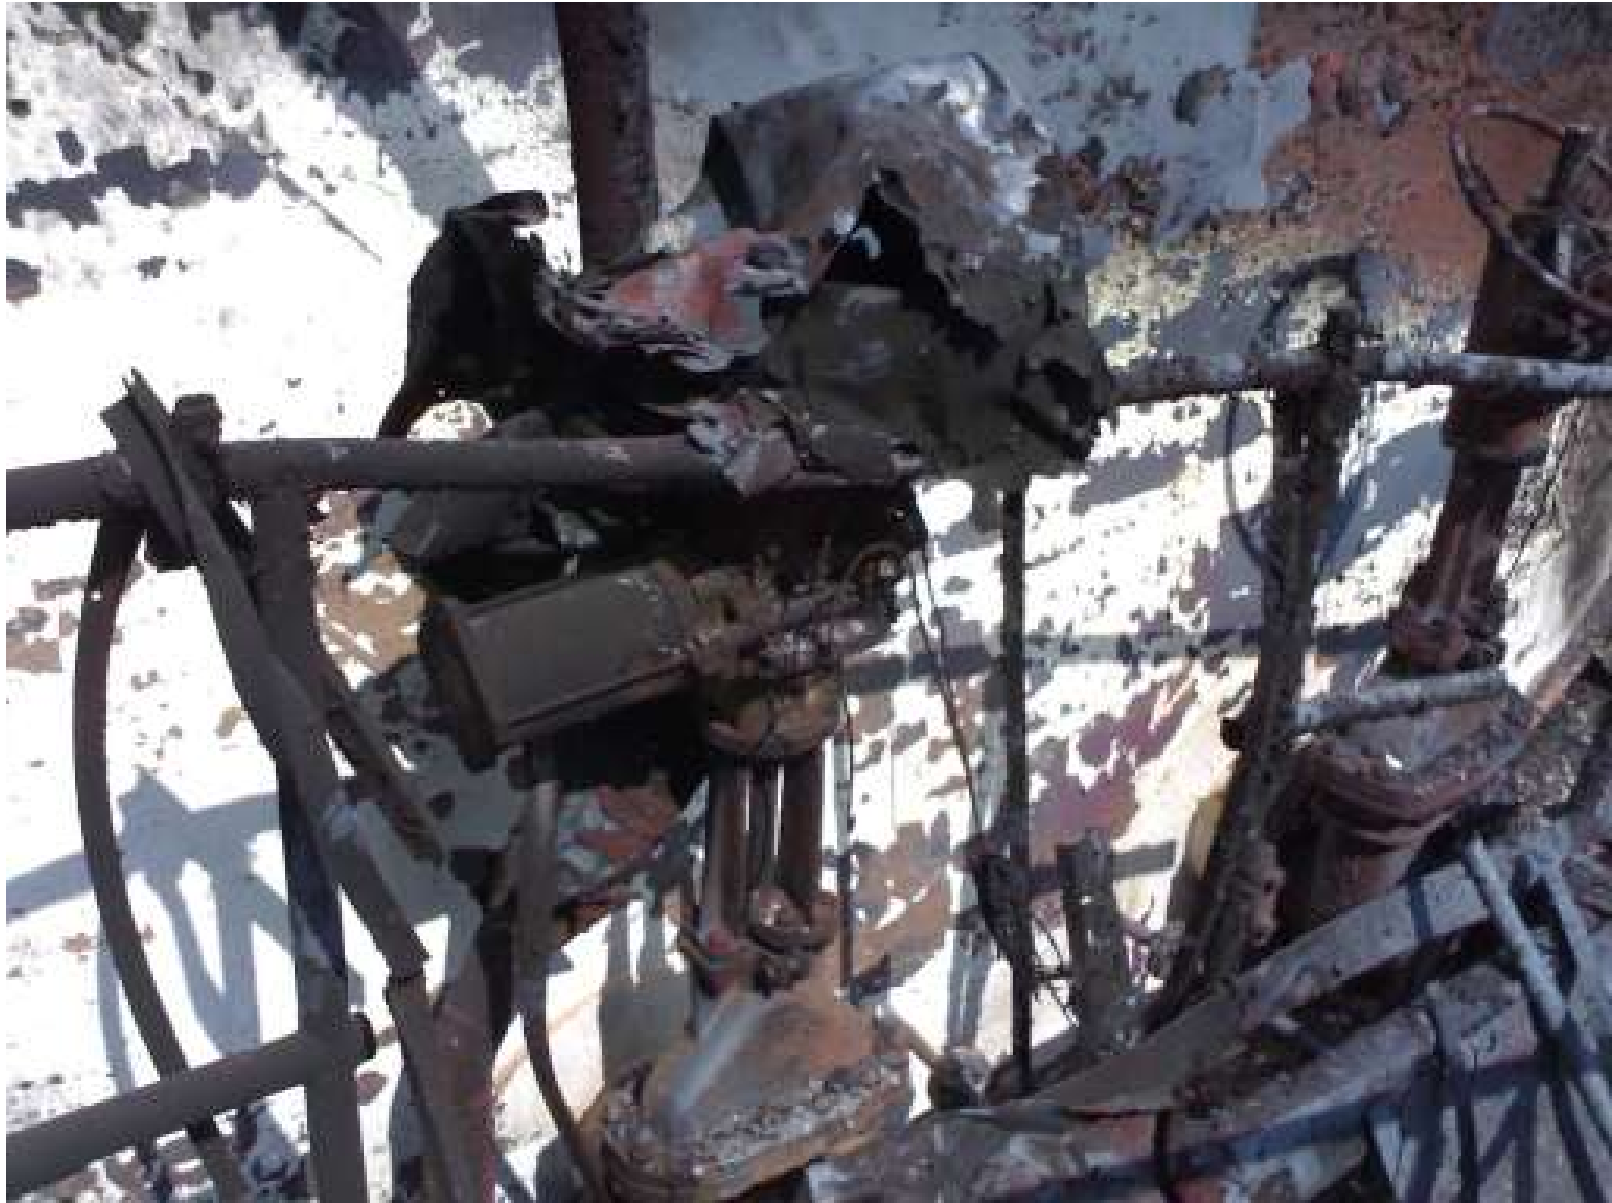
MOV on Discharge Line

- ❑ Opening of the HOV before completion of hammer blind reversal operation.
- ❑ Not checking the MOV for its open/close status and not locking it in Closed position.
- ❑ Not using proper protective equipment while attempting rescue work.

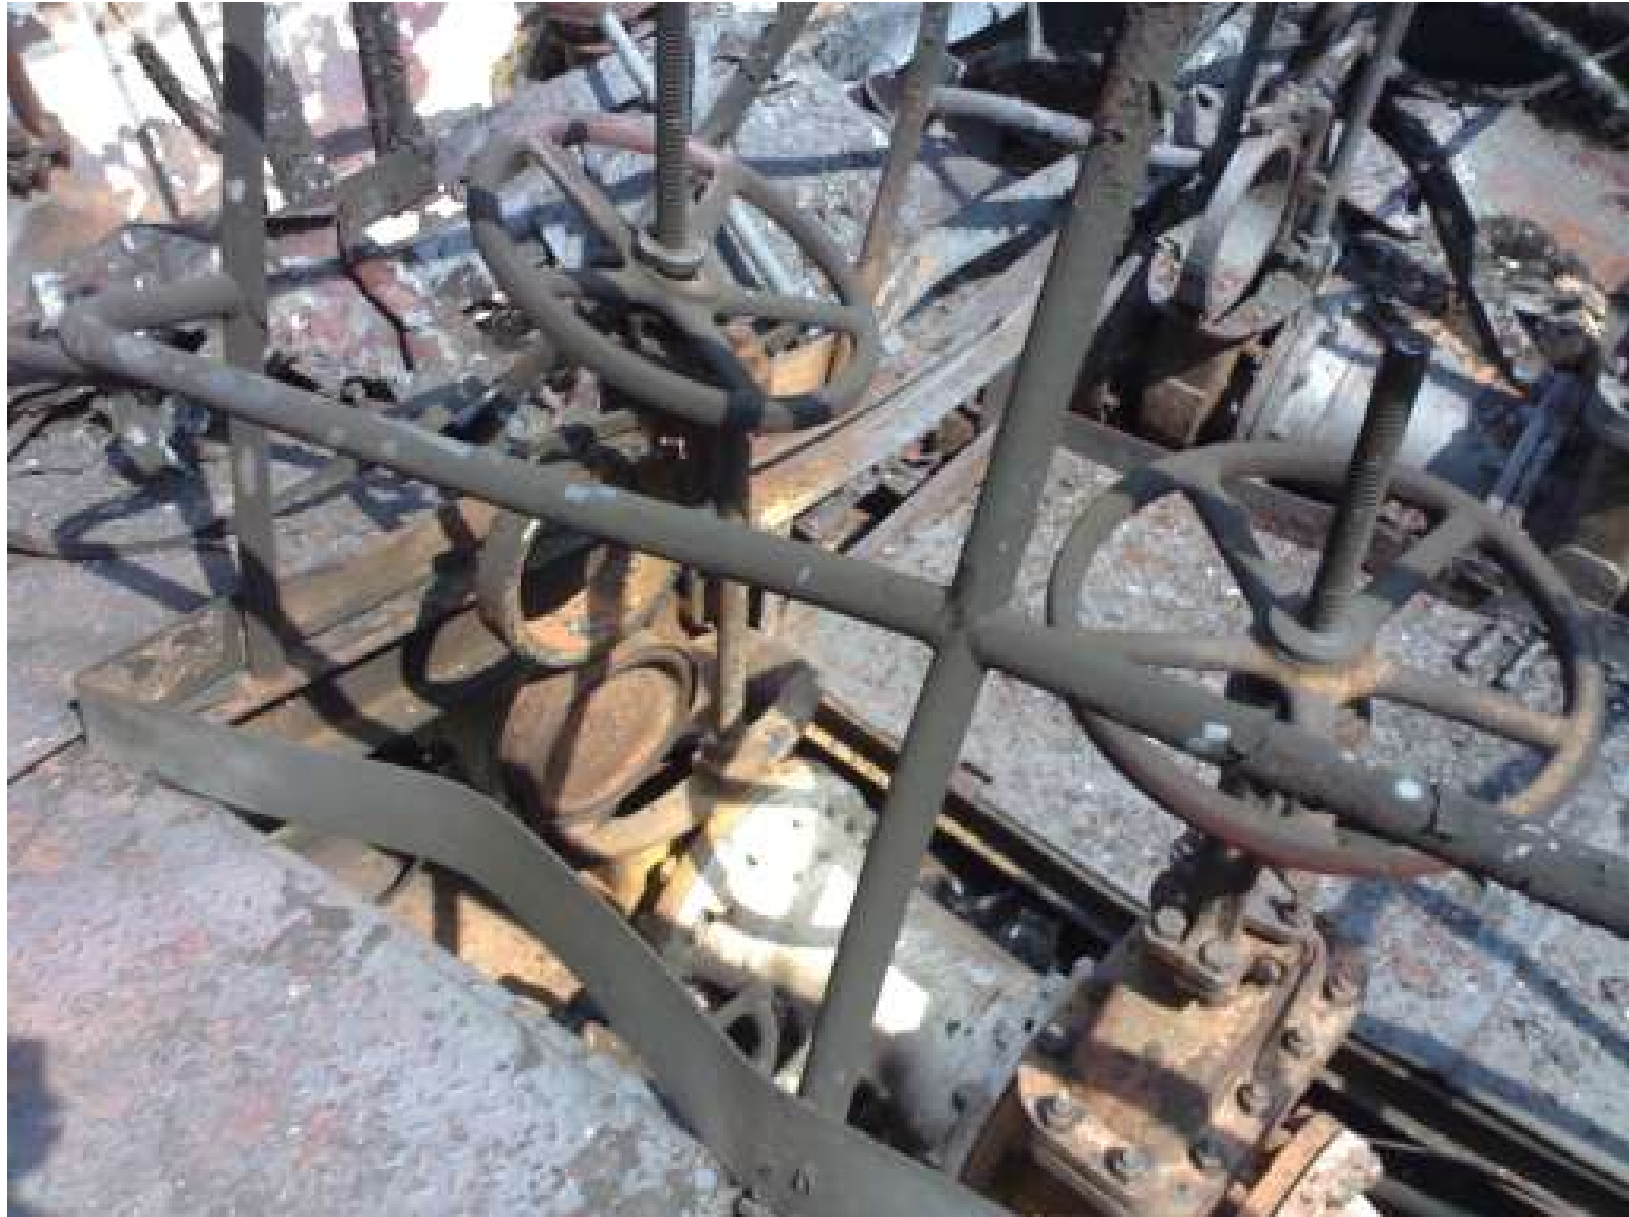
Hammer Blind and HOV on Discharge Line

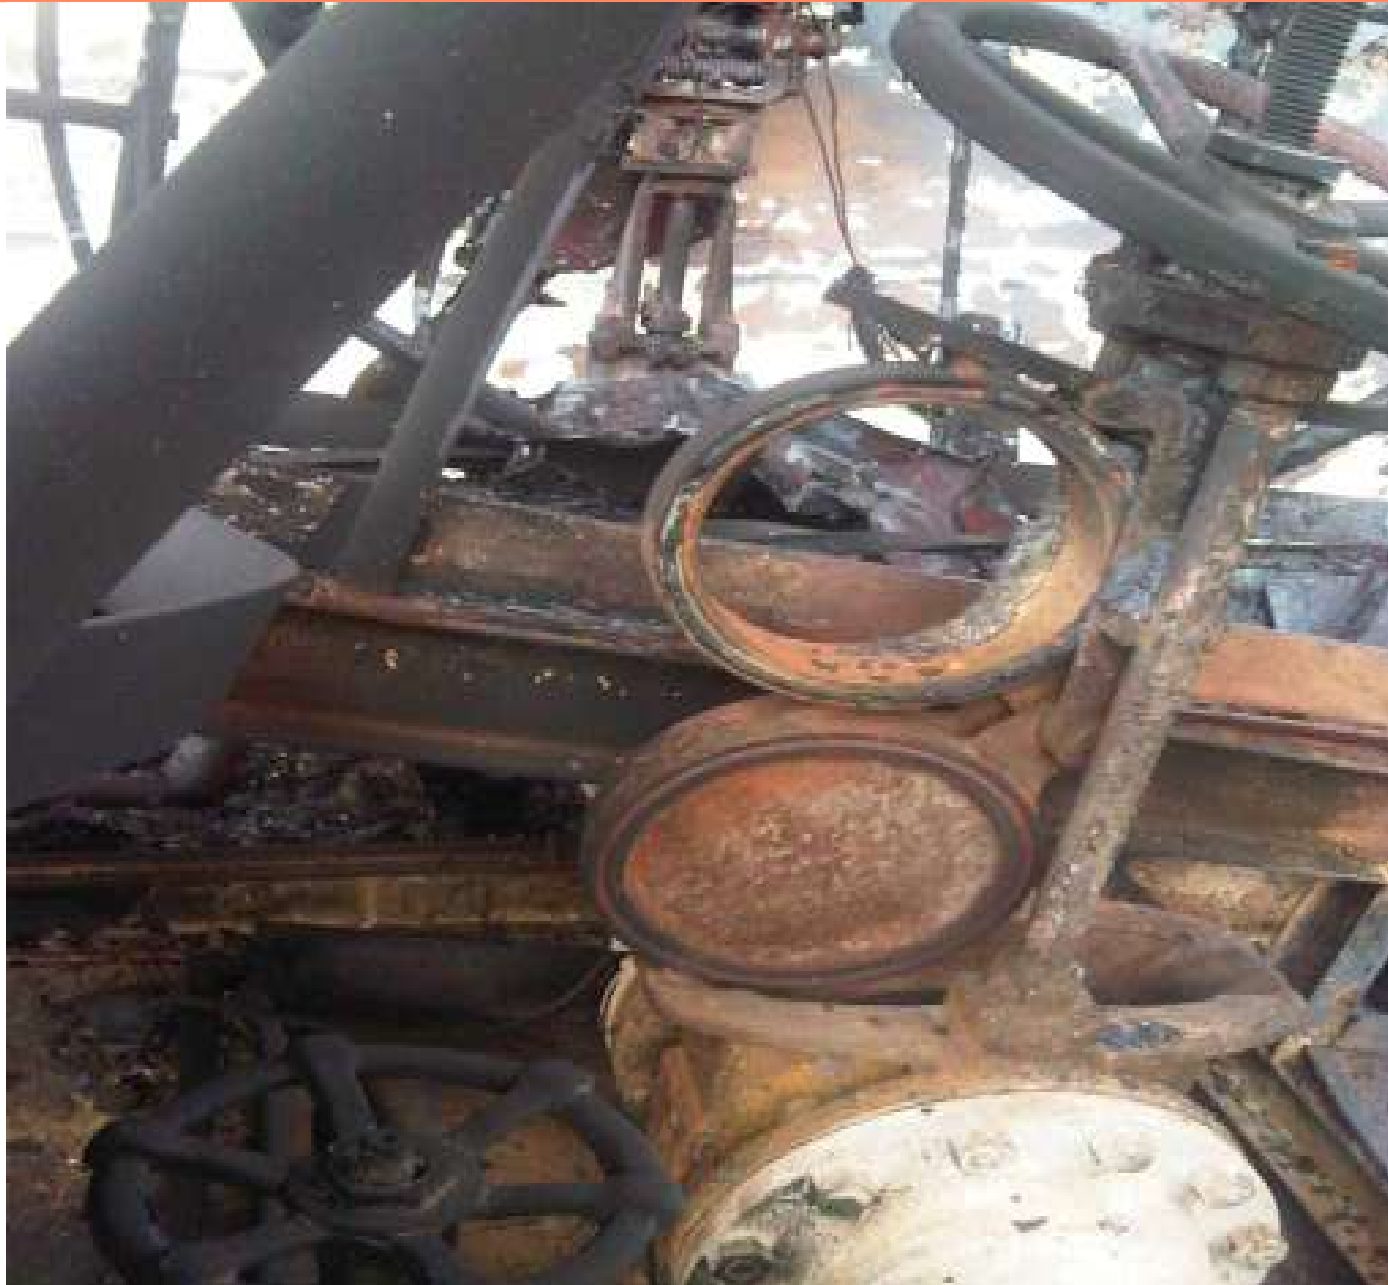
Source of MS Leak
